Workplace Fatality Summary Report:

Worker Fatally Injured when Crane Collapsed

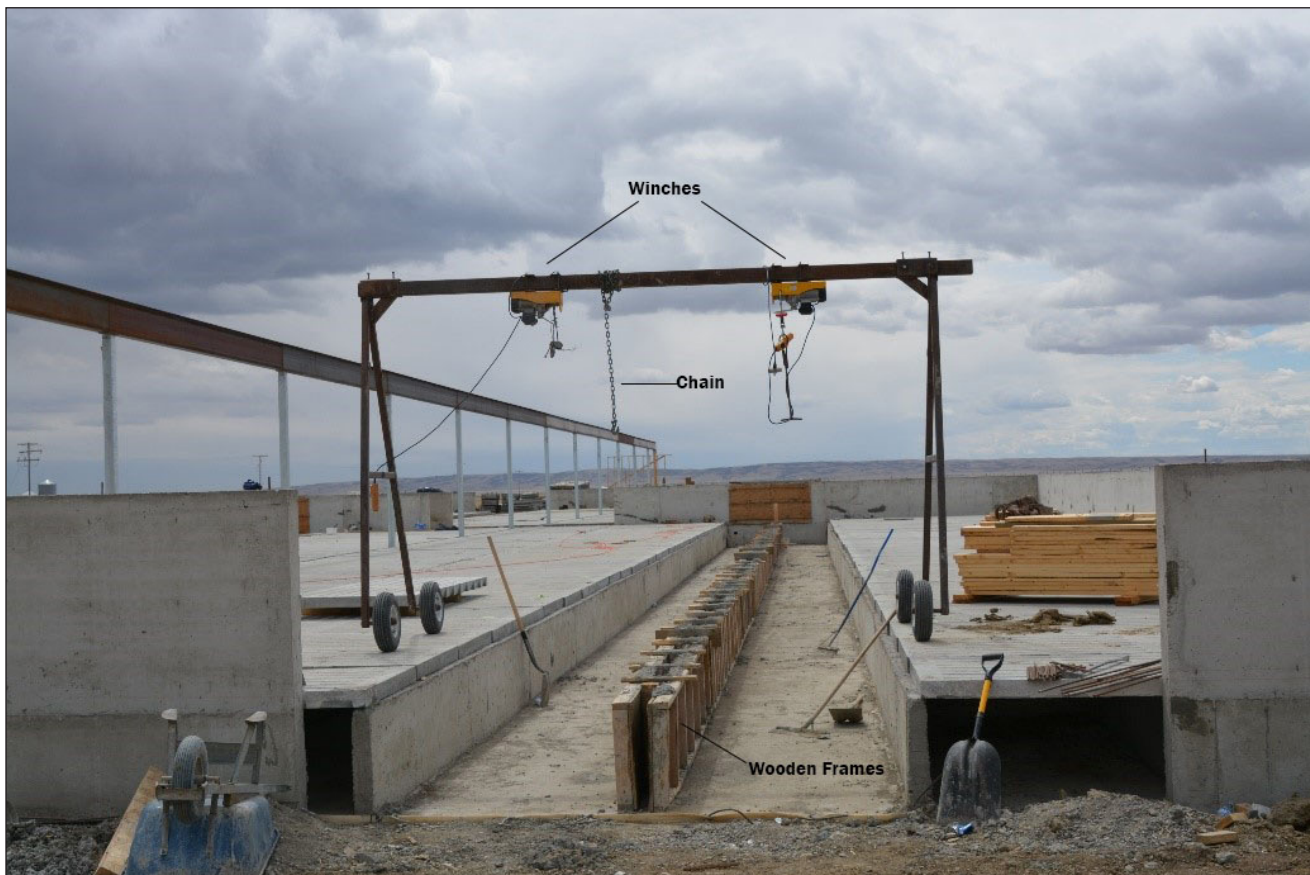
Figure 1

The crane had wheels and was erected over the hog barn's pit. Its purpose was to support an industrial metal bucket filled with concrete. The bucket was attached to a chain in the centre of the main beam and lifted into position with two winches. Two workers pushed the crane in a straight line as concrete poured out of the bucket into the wooden forms (see Figure 1).

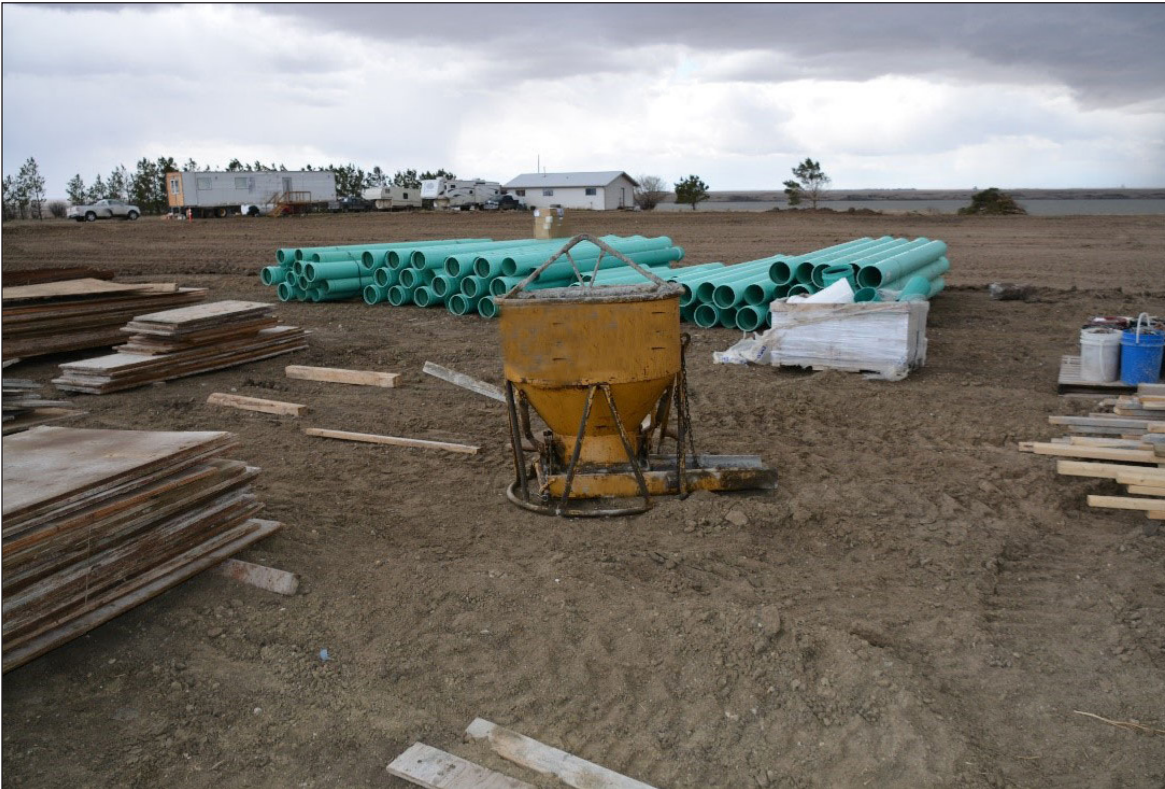
Figure 2

The industrial bucket had a hatch on the bottom. The workers opened the hatch to pour the concrete into the wooden forms. When it was empty a worker would unhook it from the chain on the crane's main beam. A telehandler, equipment similar to a forklift, was used to lift and transport the bucket to a cement truck for refills (see Figure 2).

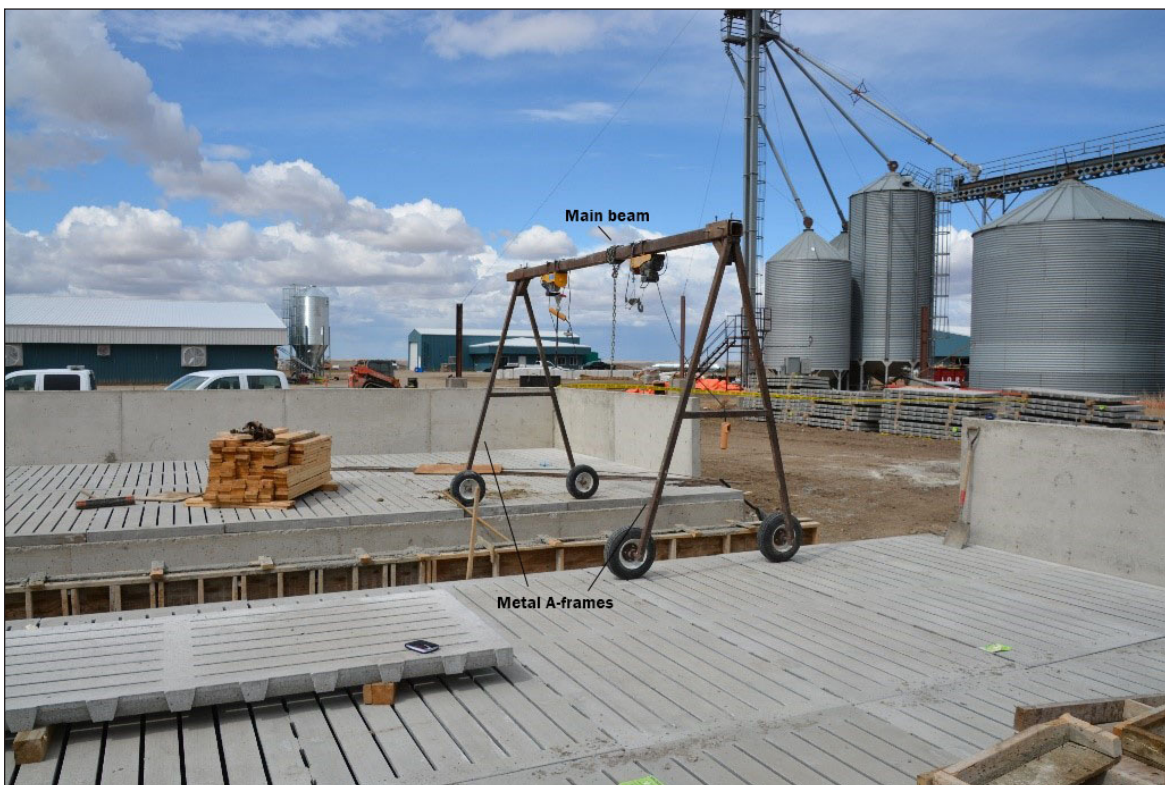
Figure 3

The crane was made of two metal A-frames connected with a main beam. Workers would grab and re-adjust the A-frames to keep the crane straight as they pushed it along the track (see Figure 3).

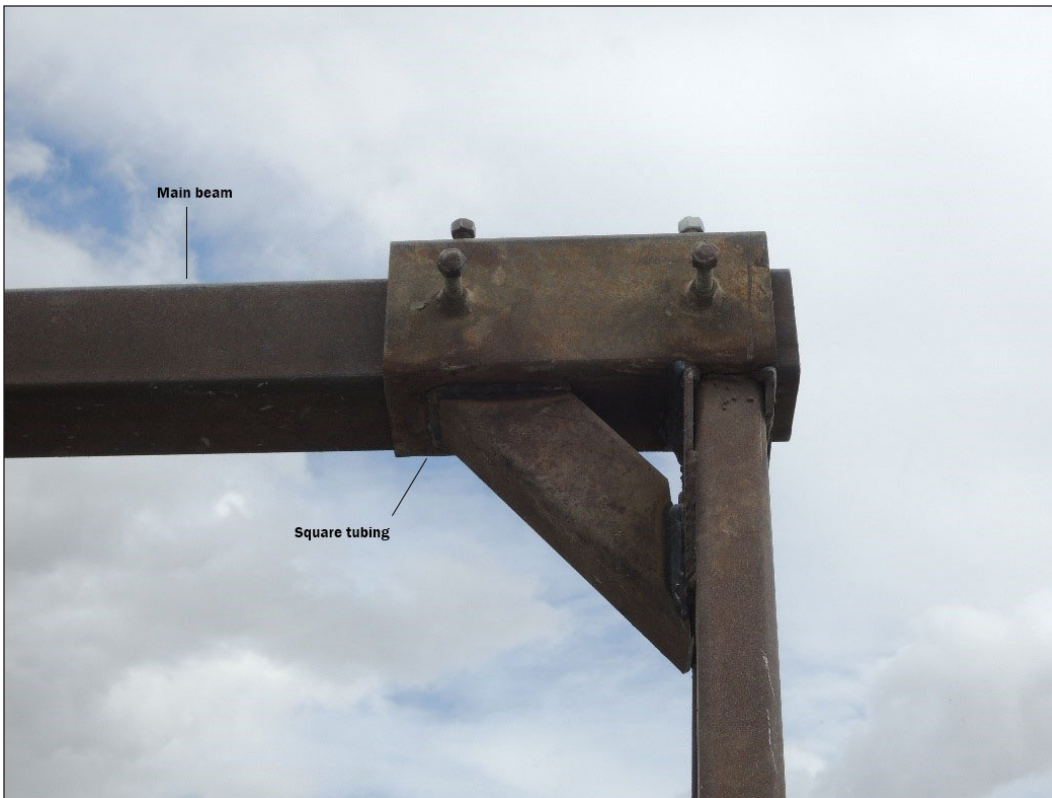
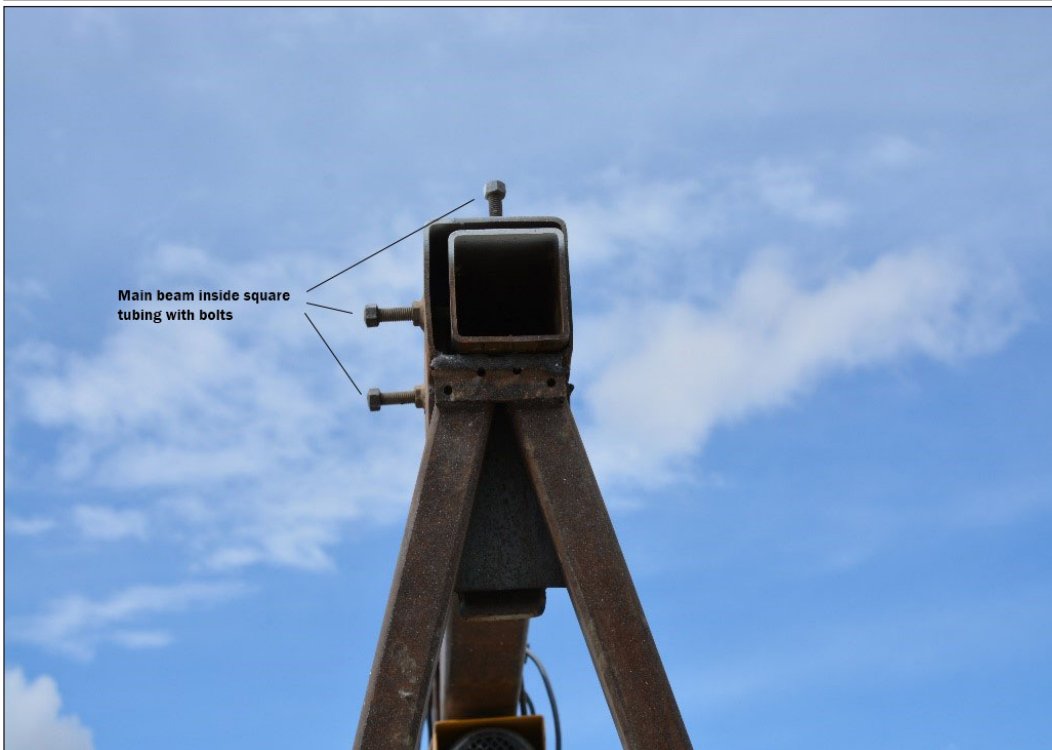
The main beam was inserted in and bolted to the A-frames' square tubing. The bolts applied pressure to the beam to wedge and hold it in place. On the day of the incident, the weight of the bucket, pushing and re-adjusting of the crane loosened the bolts' grip on the beam. Consequently, when worker 1 grabbed the A-frame to straighten the crane, it slid off the beam. The beam, still attached to the other A-frame, dropped and struck worker 1 (see Figures 4 and 5).

Worker 1 noticed the crane was crooked and grabbed the metal A-frame to re-adjust the device. The A-frame, whose bolts had loosened, slid off the main beam and toppled over. Worker 1 stumbled and fell backwards. The main beam, still attached to the A-frame on the east side of the crane, dropped, struck and fatally injured worker 1.
