Workplace Fatality Summary Report:

Worker Fatally Injured While Repairing Excavator

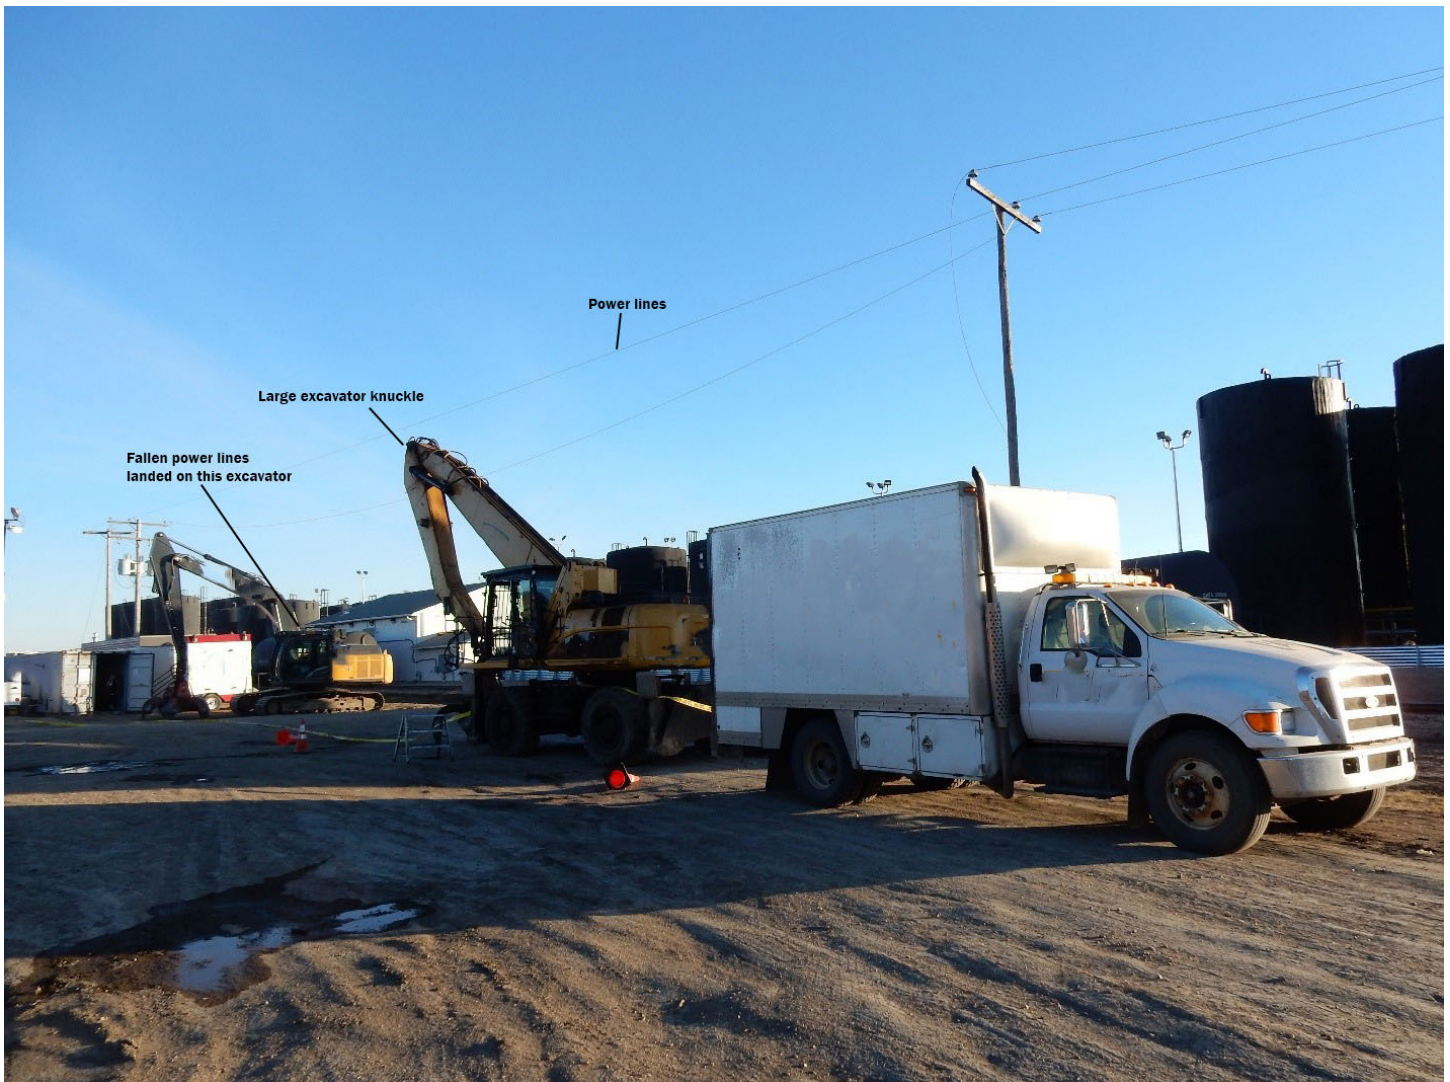
Figure 1

The excavator – a Millyard Wheel Material Handler – and the service truck were parked beside power lines on the lot. When worker 1 rotated the large excavator's tall boom to the right, its knuckle struck one of the power lines. Worker 2, who was lying on the ground under the excavator, was electrocuted. The power line fell and landed on another excavator parked nearby (see Figure 1).

Worker 2 slid under the excavator and was positioned between the front and back tires. Per worker 2's instructions, worker 1 started moving the machine forward and back, the outriggers up and down and the boom left and right. At the moment when worker 1 moved the boom to the right, its knuckle struck a power line. The line fell and landed on an excavator that was parked nearby. Worker 2, who was still beneath the machine, was electrocuted and fatally injured.
