Workplace Fatality Summary Report:

Worker Fatally Injured From Fall Through Floor Opening

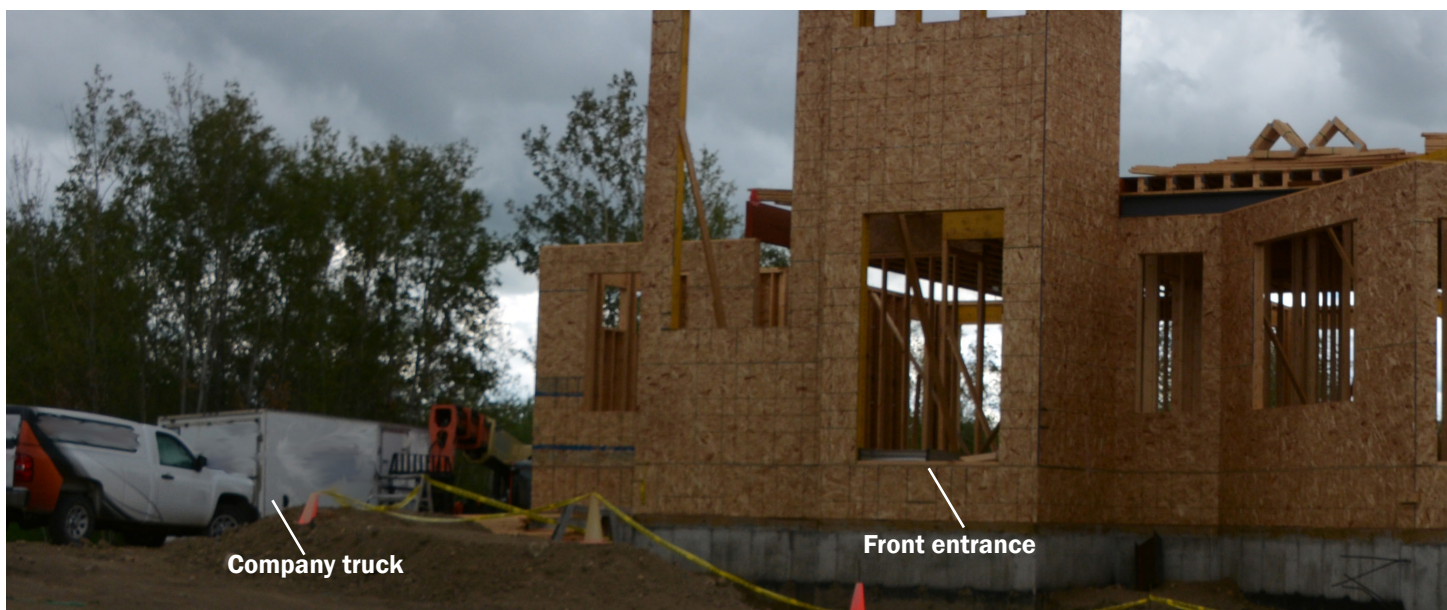
Figure 1

Although the house was partially framed, the kitchen area on the main floor could be measured. The temporary stairs leading from the ground level to the home's entrance were removed when the area in front of the home was excavated. The excavated area is marked with red cones and yellow tape. The company truck was parked beside the home adjacent to a ground level opening to its basement. (Figure 1).

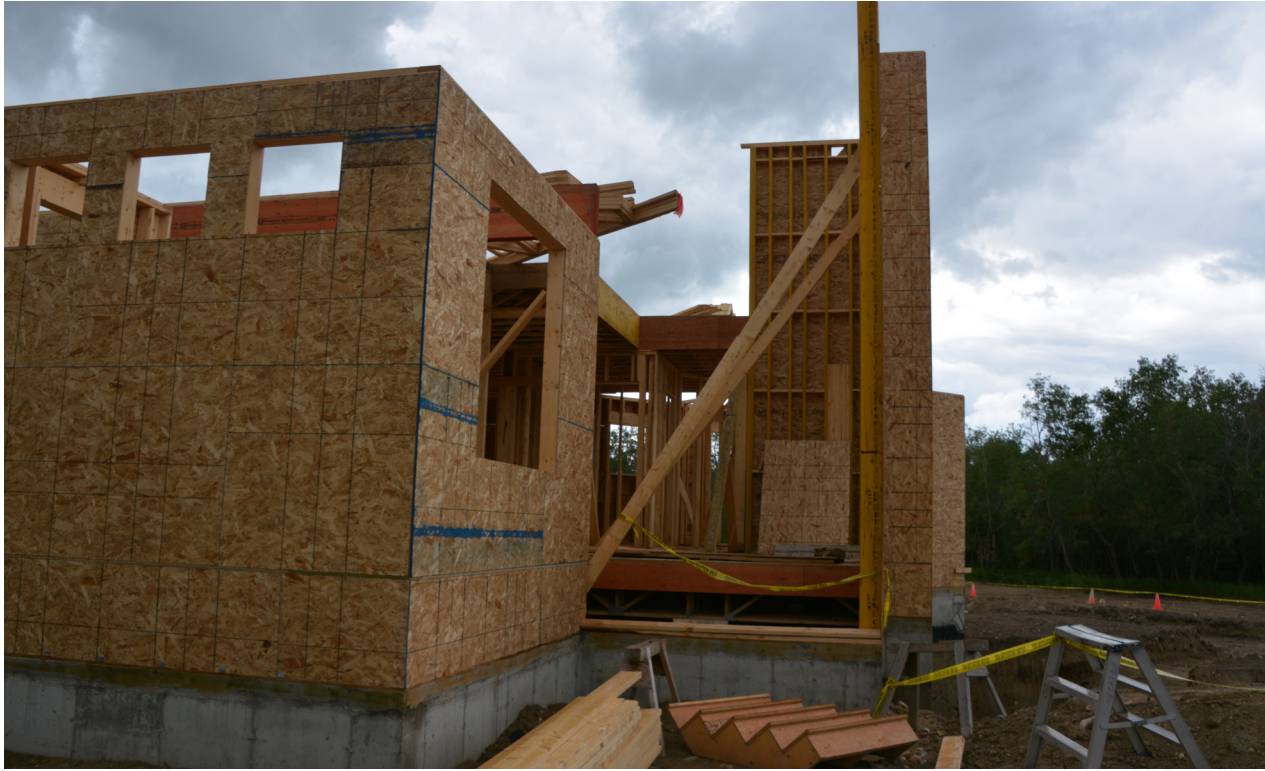
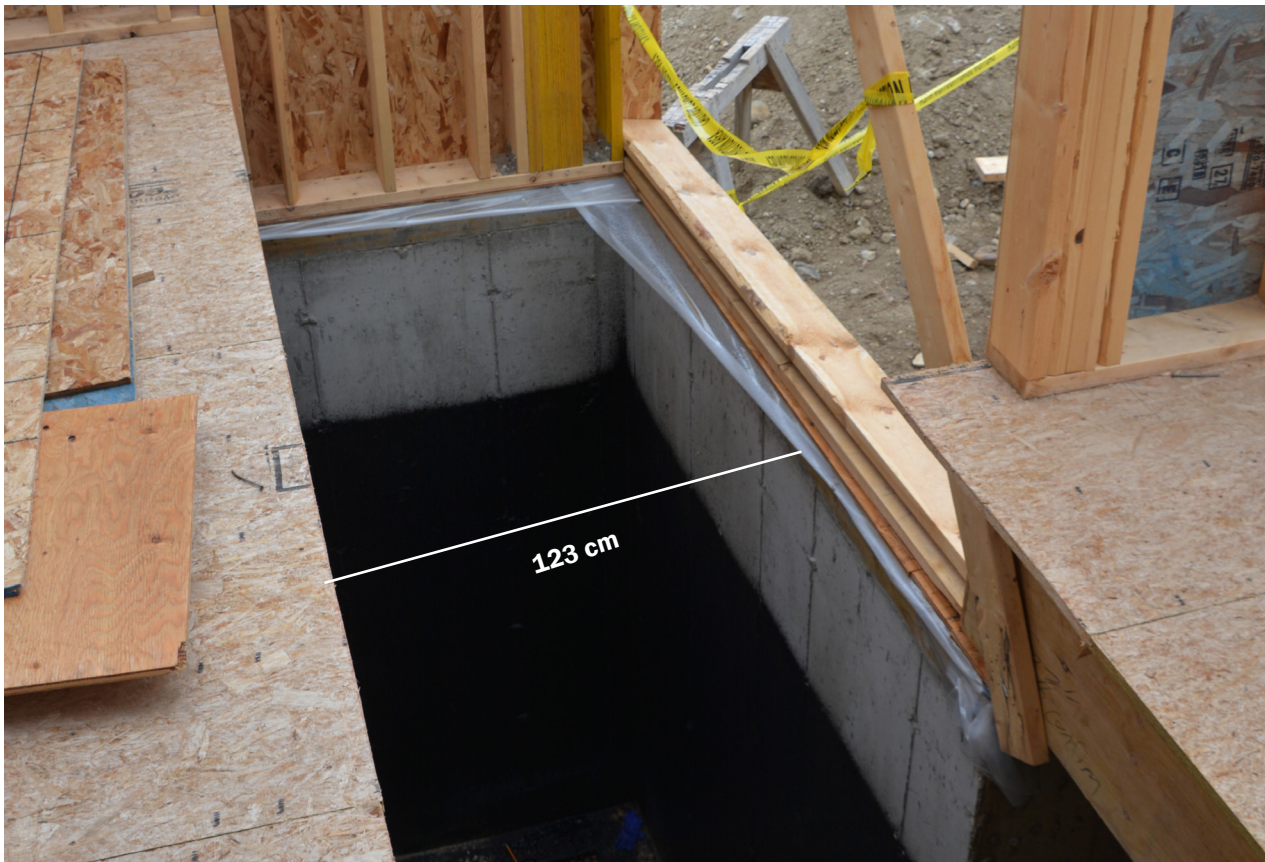
Figures 2 and 3 show the opening above the location in the basement where worker 1 was found. The width of the opening from the main floor to the exterior foundation was 123 cm (Figures 2 and 3).

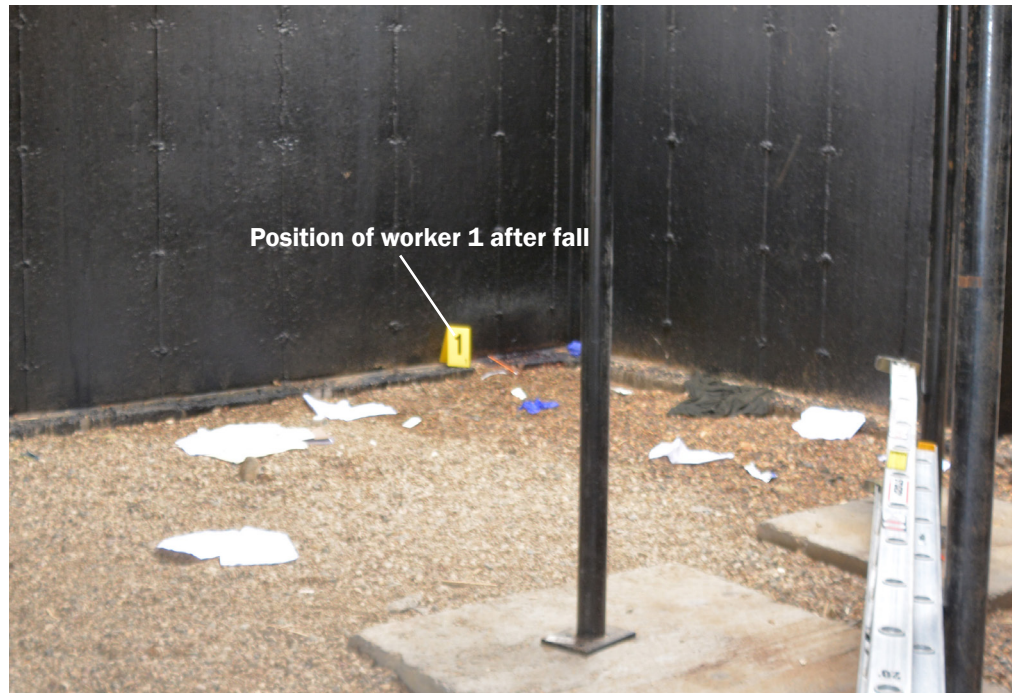
Worker 1 entered the structure through the walk-out basement because the temporary stairs leading to the home's front entrance were removed for the excavation. Figure 4 shows the opening to the main floor from the walk-out basement. The ladder worker 1 used to ascend to the main floor was placed against the home's support beams when emergency response personnel arrived. Marker 1 is the approximate location where worker 1 struck the foundation footing after the fall. Worker 1 was not wearing a hard hat at time of the incident. No protective headwear was found at the scene. The height from the top of the foundation wall to the basement floor was three metres (Figure 4).

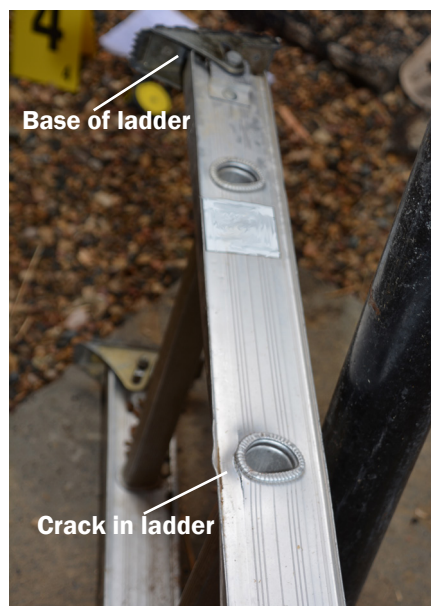
Figure 5

Investigators discovered a crack in the second rung from the base of the ladder. It is unknown whether the ladder was damaged prior to the incident and was a factor that contributed to worker 1's fall or whether the ladder was damaged when worker 1 fell through the opening in the basement's ceiling (Figure 5).
