## **Workplace Fatality Summary Report:**

### **Worker Fatally Injured by Falling Truck Box**

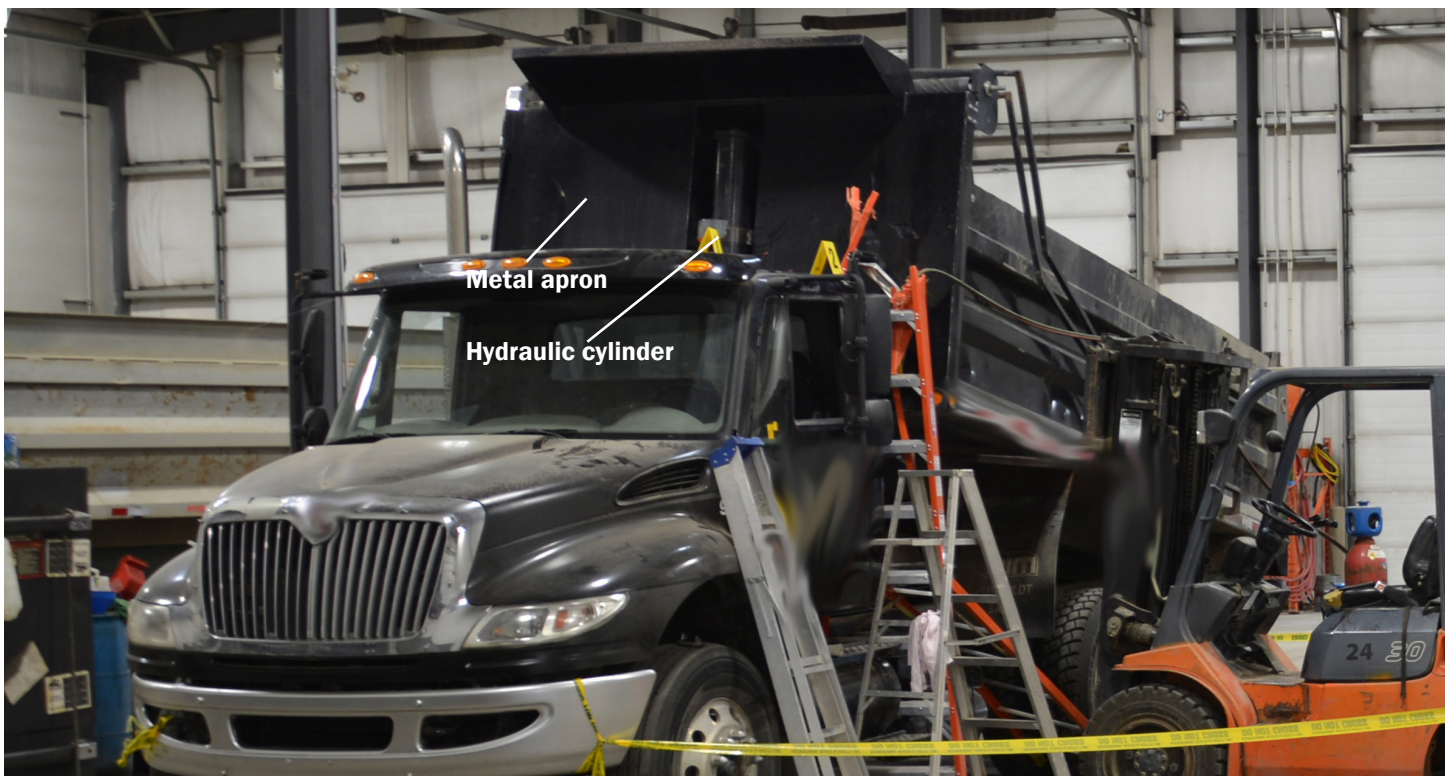
Figure 1

The type of gravel truck the worker was servicing had a metal apron on its box. The apron prevented gravel from pouring onto the truck's cab. During transport, the apron rested on the cab's roof. The worker used a ladder to access and repair the hydraulic cylinder (Figure 1).

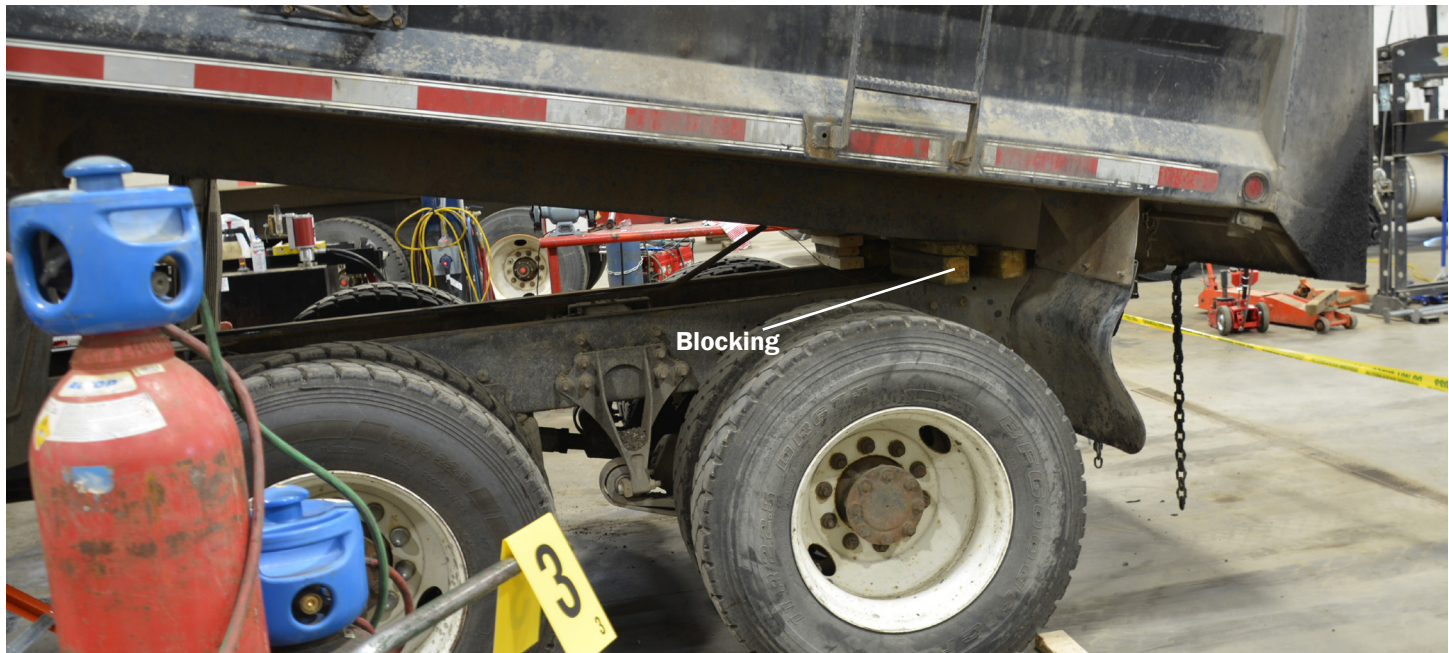
Figure 2

Blocking was used to prevent an incident while the truck was under repair. The wooden 2x4 and 4x4 inch blocks meant to secure the gravel box in a raised position were approximately 24 inches in length. Combined, the pieces were not strong enough to effectively support the weight of the gravel box from one side of the truck's frame to the other (Figure 2).

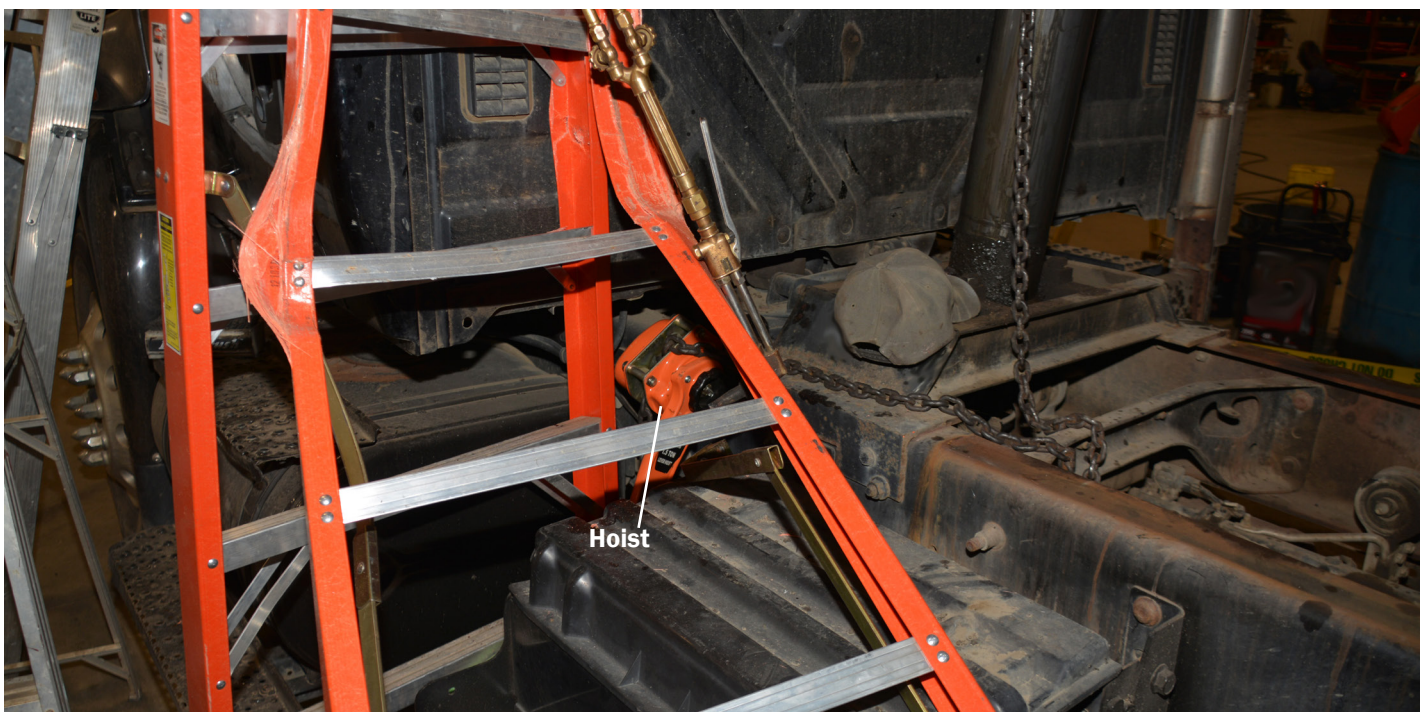
Figure 3

This portable metal chain was attached to the gravel box's upper frame in an attempt to force it downwards when it jammed and could not be lowered (Figure 3).

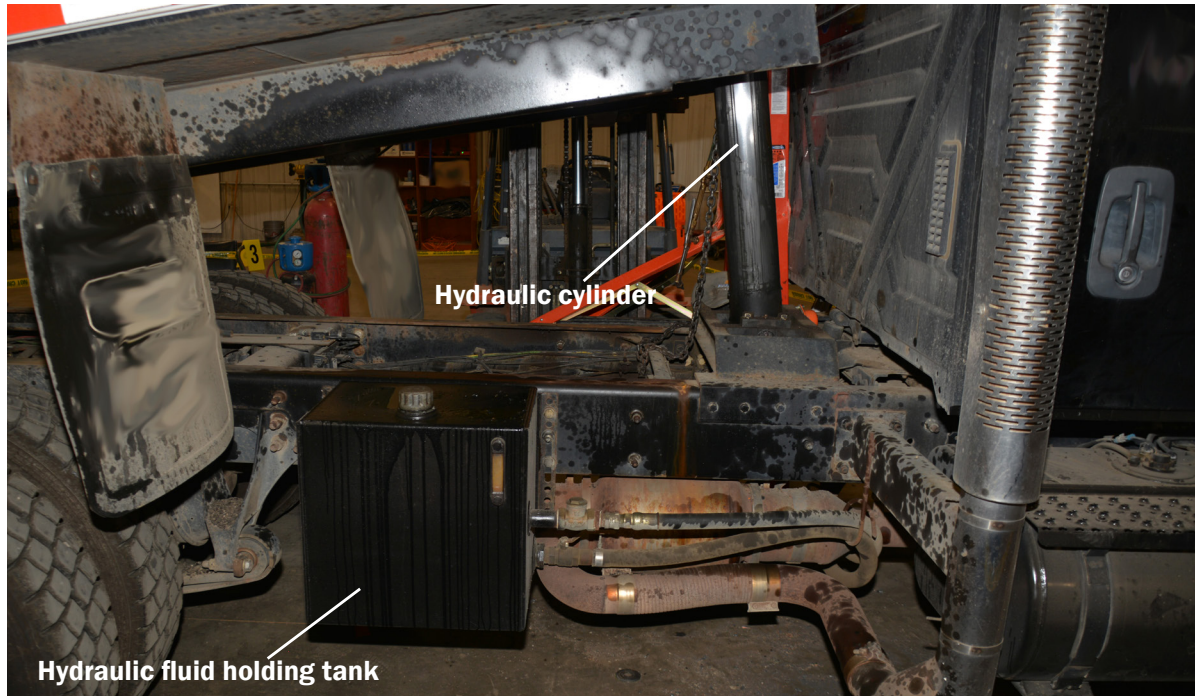
Figure 4

The gravel box was controlled through hydraulics. Oil filled the hydraulic cylinder to raise the gravel box and then drained back into the hydraulic fluid holding tank when it was lowered. The day before the incident, the worker placed the gear shift for the hydraulic cylinder in the downward position to lower the box. The oil drained out of the cylinder and back into the hydraulic fluid holding tank overnight. With no oil in the cylinder, the shop-fabricated steel band was the only thing supporting the cylinder and gravel box's weight (Figure 4).

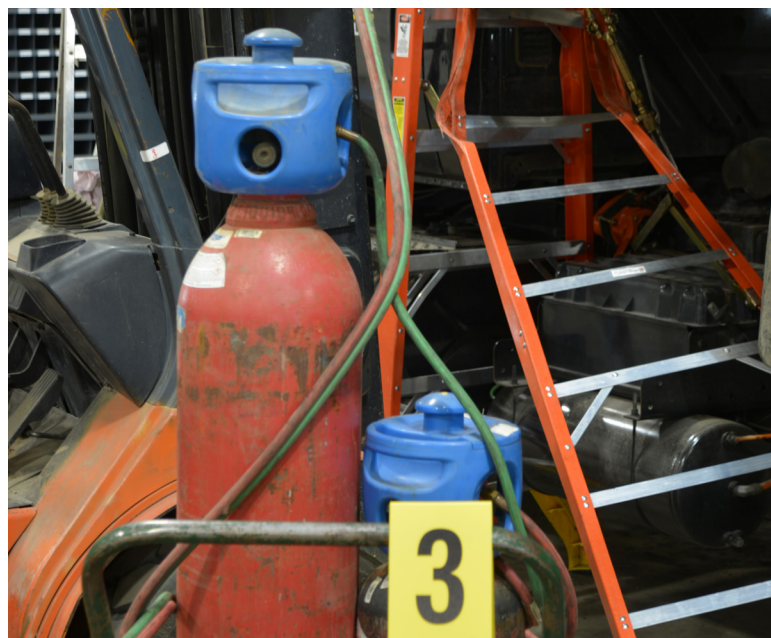
Figure 5

A canister of oxy-acetylene gas fueled the torch the worker was using to remove the steel band. Oxy-fuel torches are commonly used in the automotive industry for iron and steel welding, rust and scale removal, loosening and removing corroded bolts, and cutting ferrous metals (Figure 5).

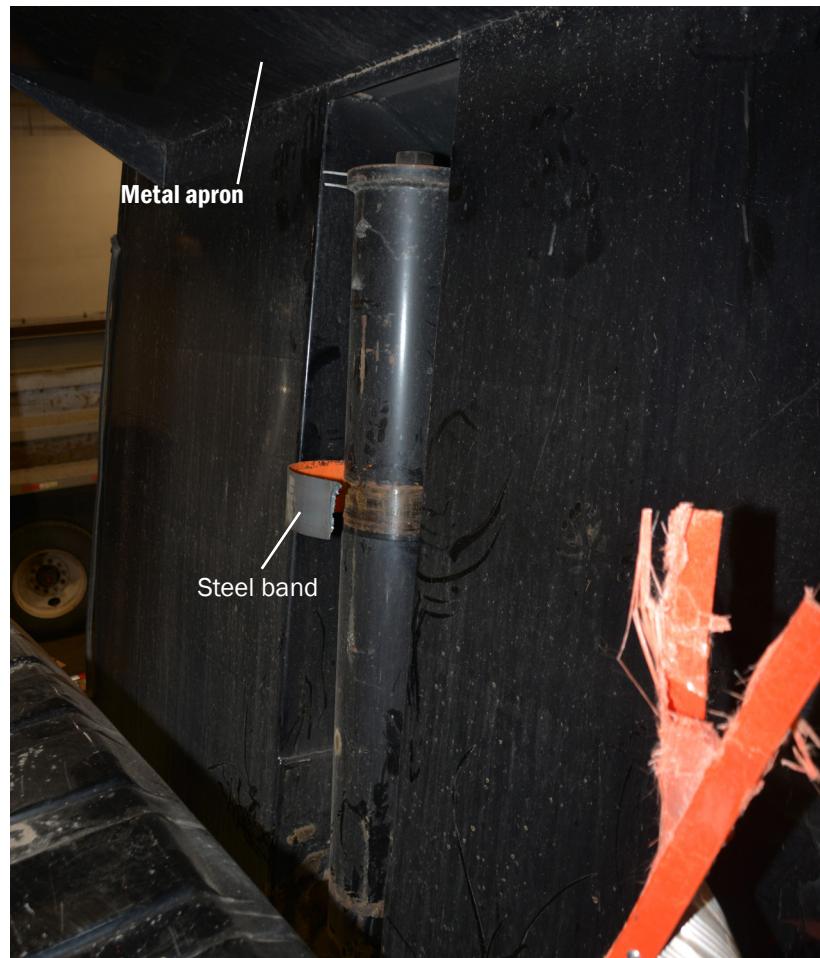
Figure 6

The 4x12 inch shop-fabricated steel band was installed to prevent the hydraulic cylinder from banging during transport. The gravel box could not be lowered because the band was holding the hydraulic cylinder on the wrong angle – it had to be removed. As the worker cut through the steel band with the torch, the weight of the cylinder and the gravel box leaning against the band made it break (Figure 6).

A close examination of the events leading to the incident revealed that the steel band did not need to be installed – the truck was manufactured with a bracket and four bolts for adjusting the cylinder. The gear shift for lowering the gravel box was left in the downward position when the workers went home the previous evening. The hydraulic oil drained back into the hydraulic fluid holding tank overnight. With no oil in the hydraulic cylinder, the steel band was the only mechanism supporting the weight of the cylinder and the gravel box while in the raised position. When the steel band broke, the cylinder – that the band was holding – straightened and then fell. The wooden blocking was not strong enough to withstand the weight of the gravel box when it crashed onto its cradle.
