Workplace Fatality Summary Report:

Worker Fatally Injured While Test Driving A Snowmobile

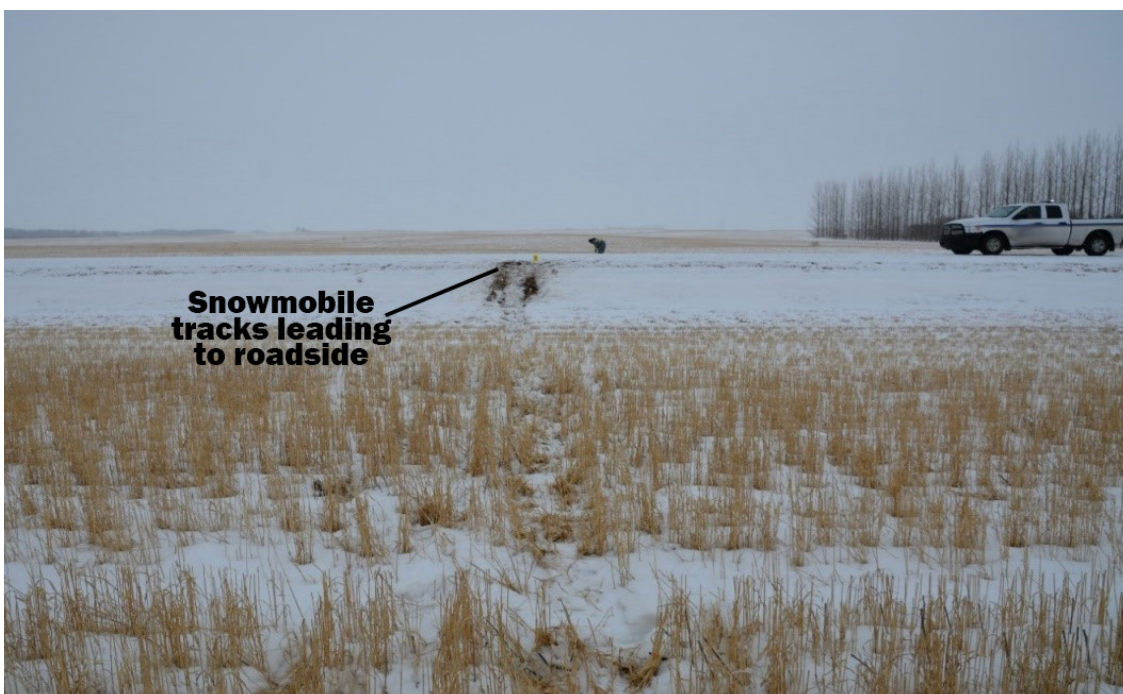
Figure 1

The snowmobile was light-weight for riding in deep snow, had a 160 horsepower engine and a manufactured maximum speed rating of 120km/hour. The tracks leading to the embankment and location where the snowmobile landed, revealed it was moving quickly west-ward when it made contact with the roadside embankment. The force of the collision propelled both the machine and the worker into the air and over the road. There were no tracks leading to the location where the snowmobile hit ground, which was 41 metres away from the point of impact in the field on the east side of the road. The snowmobile glided, came to a stop and was found idling 13 metres from where it had landed (see Figures 1 - 3).

Investigators determined that the west-ward moving snowmobile hit a roadside embankment at high speed. The impact from the collision propelled the machine into the air and over the road where it struck the ground, glided and eventually came to a stop. The worker was thrown from the machine when it landed and was fatally injured.

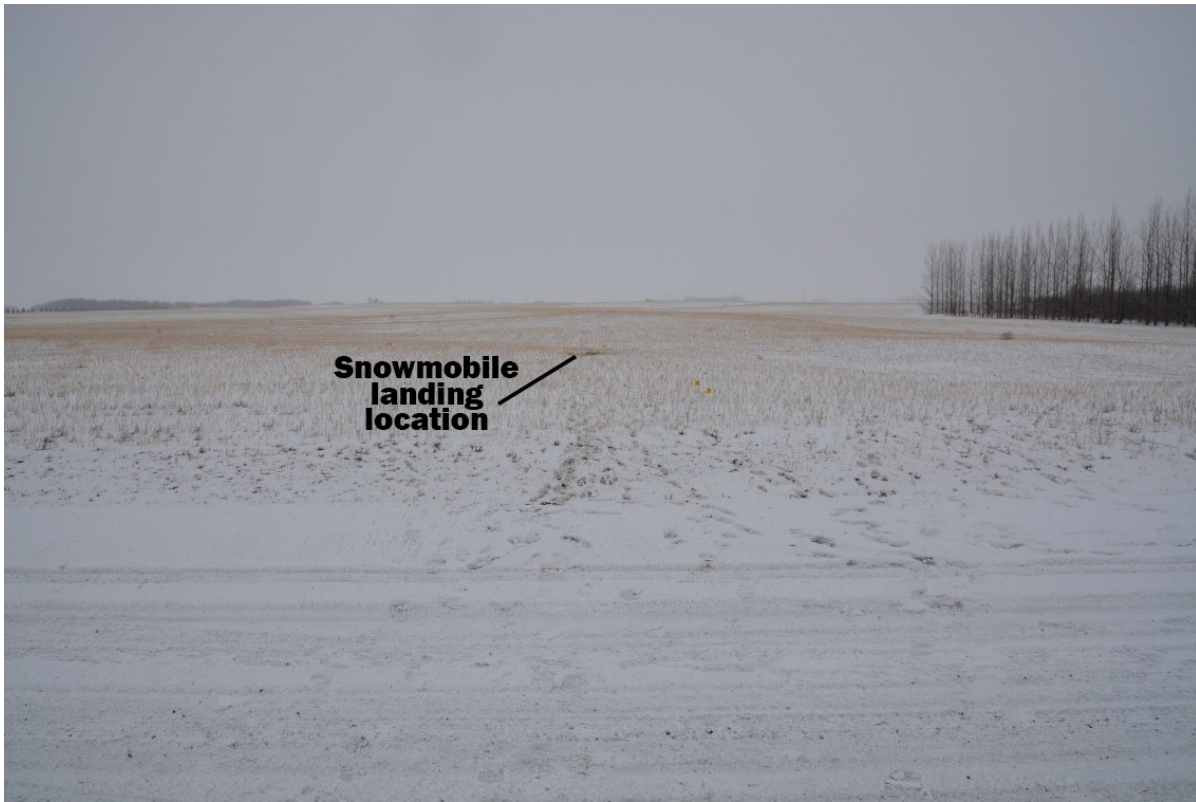
Figure 2: Distance from point of impact to location where snowmobile landed

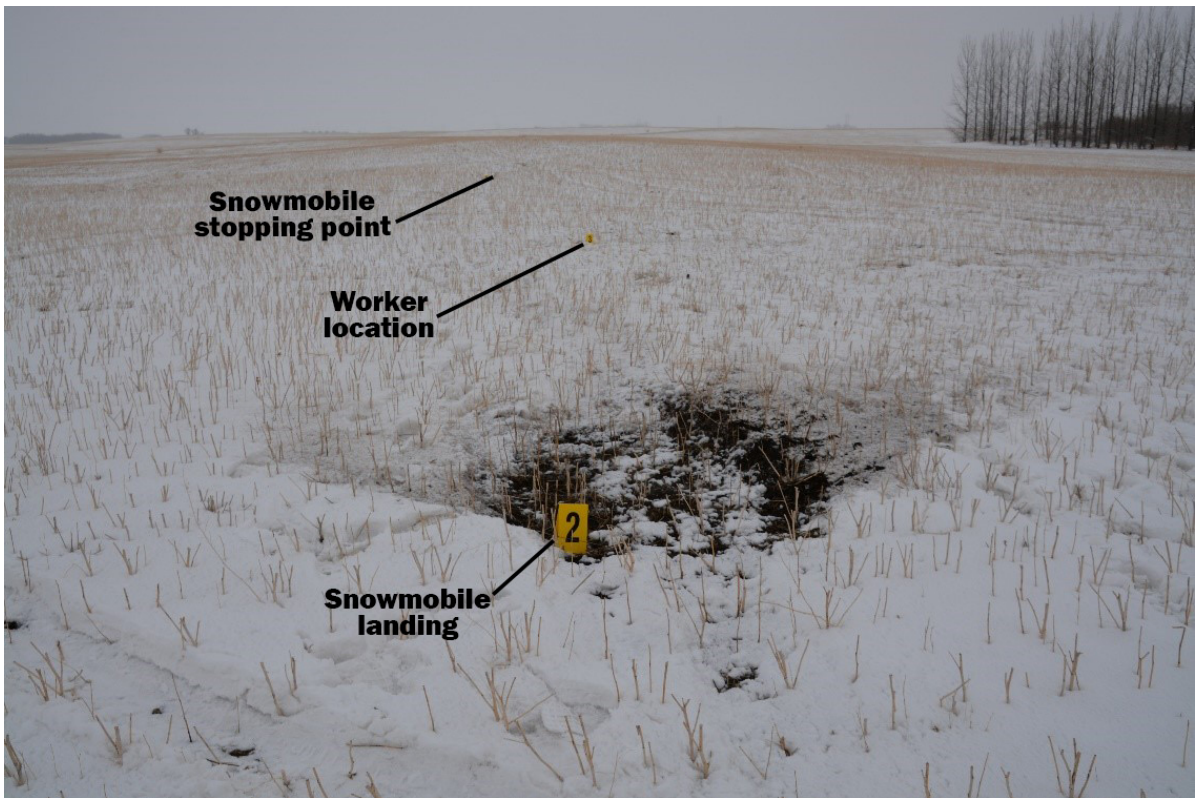
Figure 3: Distance from where snowmobile landed to where it stopped

A short time later, the employer spotted the snowmobile idling on an adjacent property with the worker lying approximately 30 metres away from the machine.
