Workplace Fatality Summary Report:

Worker Fatally Injured while Clearing Rock Crushing System's Chute

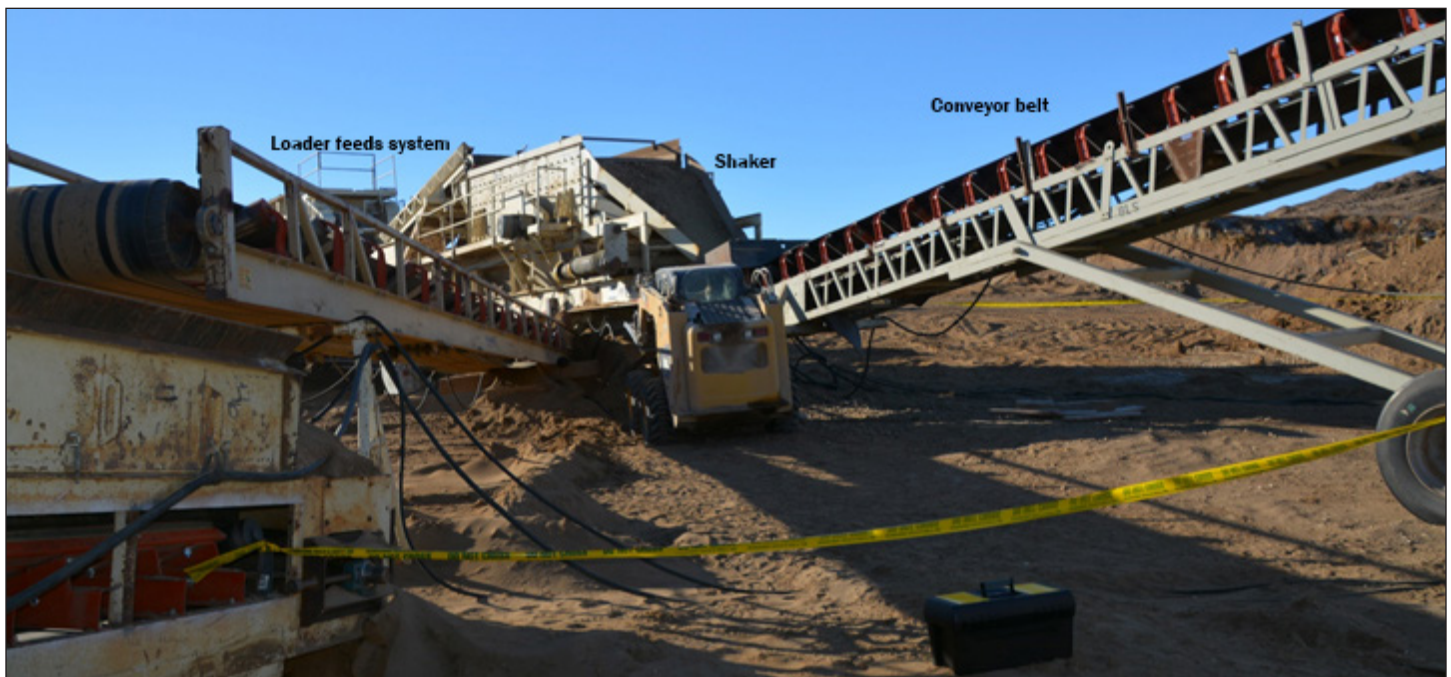
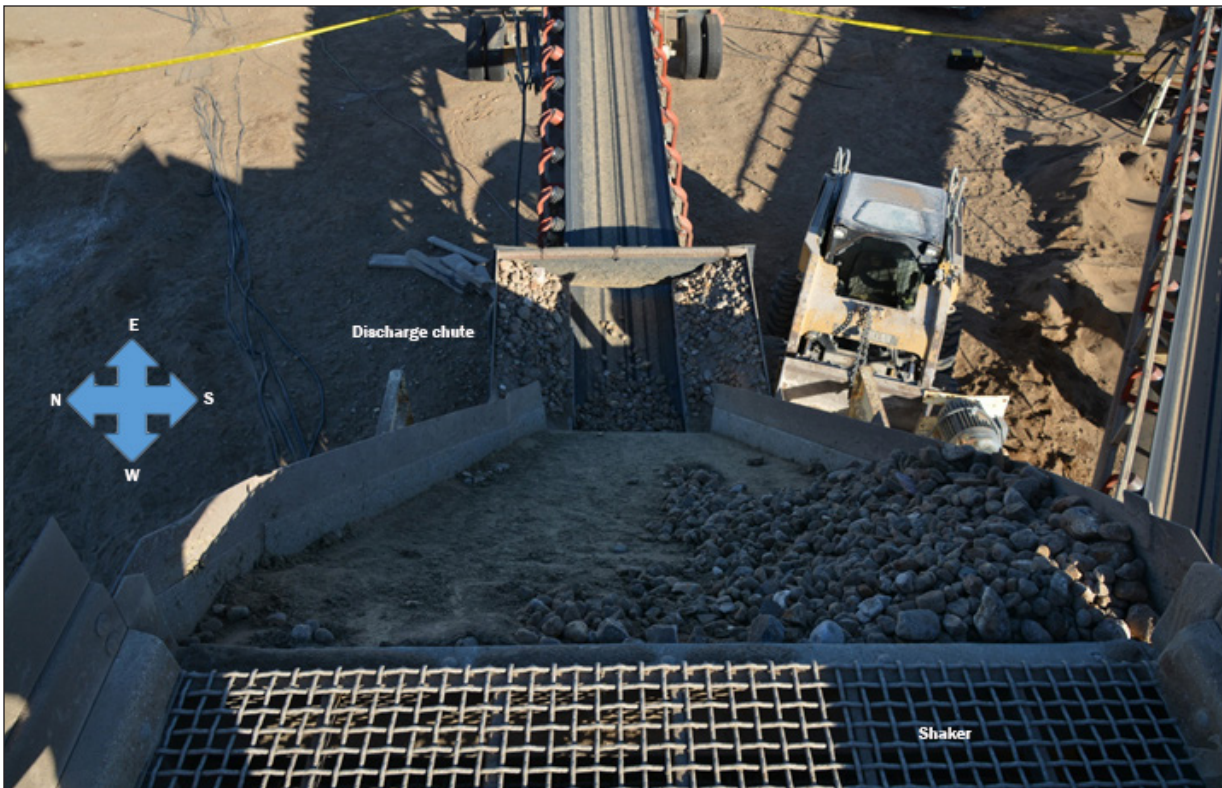
Figure 1

This collection of equipment has several components and is used in gravel pits to create crusher dust, an aggregate product which is 5/8th sand and dust. Workers use loaders to feed material into the system. A shaker (or, vibratory screen) separates the rocks and sand. Then the material slides through the discharge chute and onto the conveyor belts. The rocks travel down one belt and the sand travels down another (Figures 1 and 2).

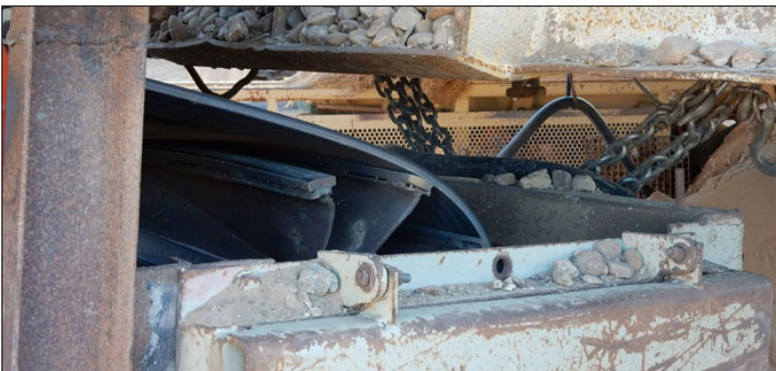
Figure 3

The tail pulley is the mechanism that turns the conveyor belt and keeps it in motion. At the time of the incident the part was unguarded (Figure 3).

At that moment worker 2 slipped, landed on the conveyor belt's unguarded moving tail pulley and became entangled in the machinery.

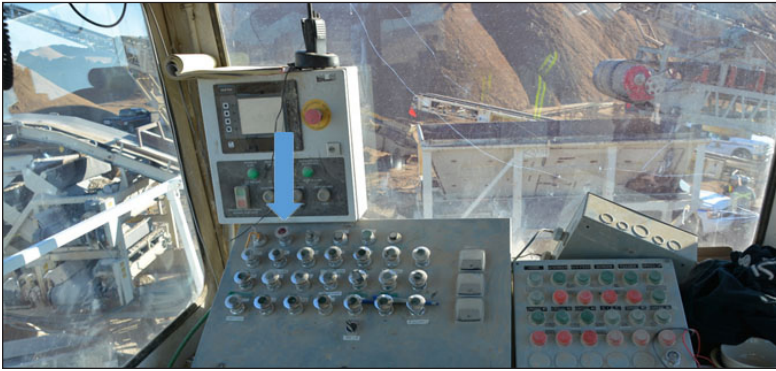
Figure 4

The computer in the control tower monitors the entire crusher spread. When equipment is blocked or parts are malfunctioning, the operator radios workers on the ground for assistance and shuts down the affected locations, or presses the emergency stop switch to shut down the entire crusher spread (Figure 4).

Another worker who was operating a front end loader close-by, parked the equipment and, hit the emergency stop switch in the control tower shutting down the entire crusher spread.
