Workplace Fatality Summary Report:

Worker Fatally Injured When Trench Caved In

A worker repairing a sewer line was fatally injured when the trench walls caved in.

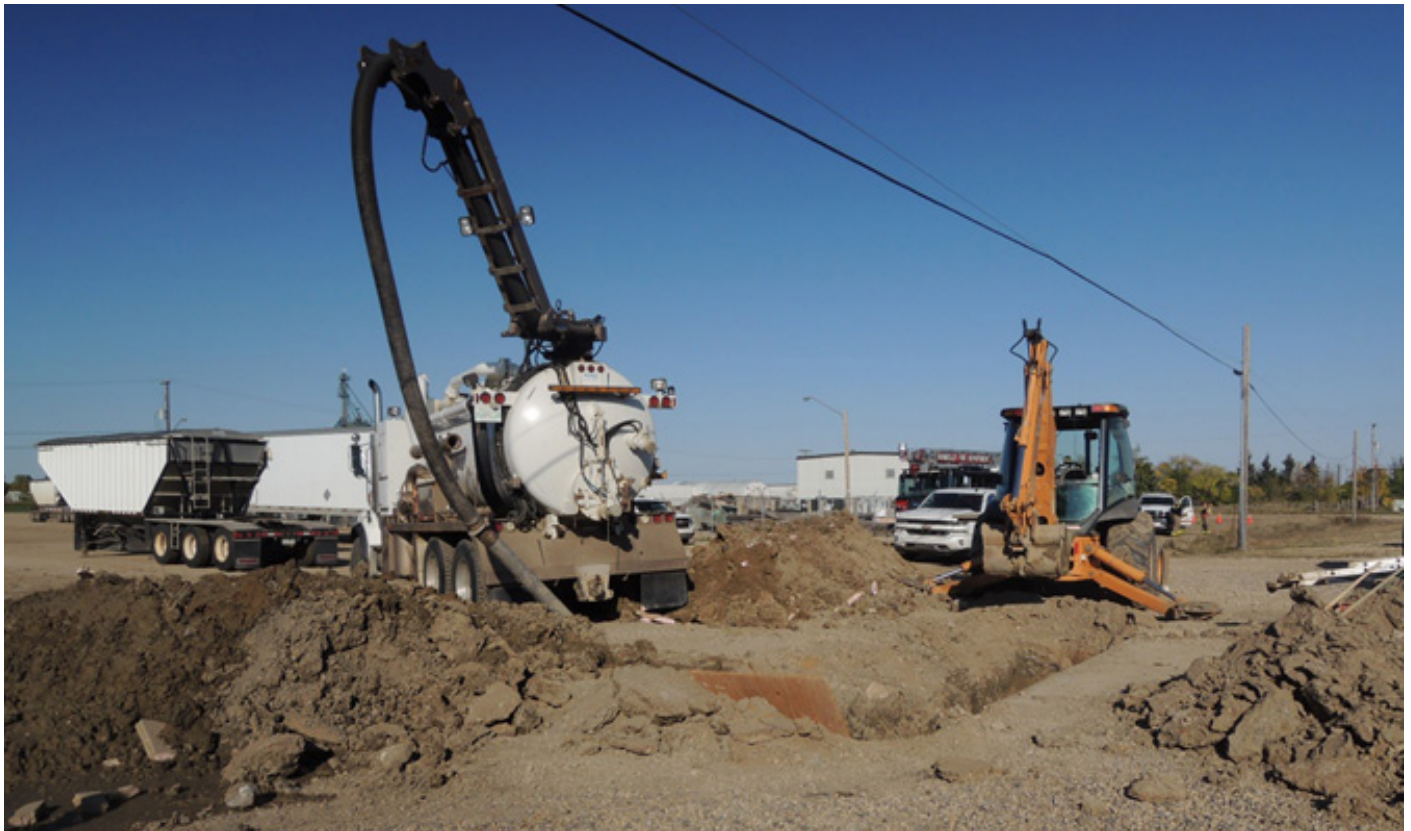
Figure 1

This photograph provides a view of the entire worksite. The sewer jet truck was parked next to the excavation for the purpose of flushing dirt, sand, and debris out of the damaged sewer line with high-pressure water (Figure 1).

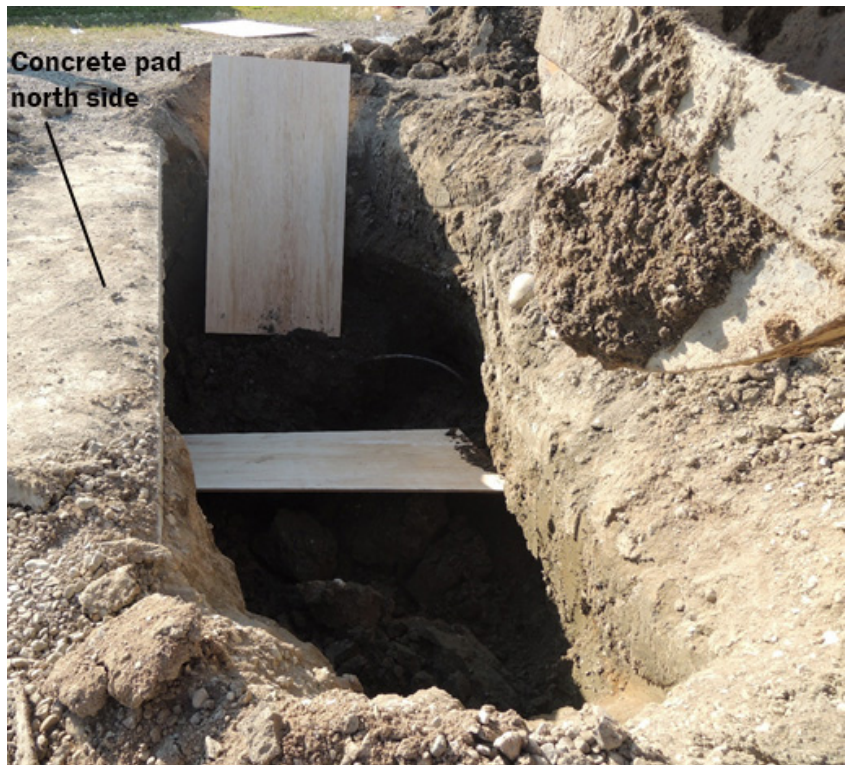
Figure 2

The trench – located at the end of a driveway – was 2.31 metres wide, 2.54 metres deep and 5.92 metres long.

This photograph reveals that the trench's walls were not cut-back, and no protective structure was installed to prevent a cave-in.

Voids from where the saturated sheets of earth fell are visible under the trench's north and south sides (Figure 2).

It was determined that the employer was familiar with the condition of the trench before the work began. The trench walls were cut straight down from the concrete pad. With no cutback and protective structure to prevent a cave-in, the trench was unsafe for workers to enter.

The employer plead guilty to subsection 263(1) of *The Occupational Health and Safety Regulations, 1996*, being an employer failed to ensure that a worker present in a trench that is more than 1.2 metres deep, is protected from cave-ins or sliding material by cutting back the upper portion of the walls of the trench in accordance with subsection 260(2); installing a temporary protective structure; or a combination of cutting back the walls to the slope specified in subsection 260(2) and installing a temporary protective structure that extends at least 300 millimetres above the base of the cut-back, resulting in the death of a worker. The employer was fined \$95,000 plus a victim surcharge of \$38,000.
