Workplace Fatality Summary Report:

Worker Fatally Injured by Unguarded Equipment

A worker was fatally injured after their clothing became caught in a grain mill's unguarded power take-off shaft (PTO shaft).

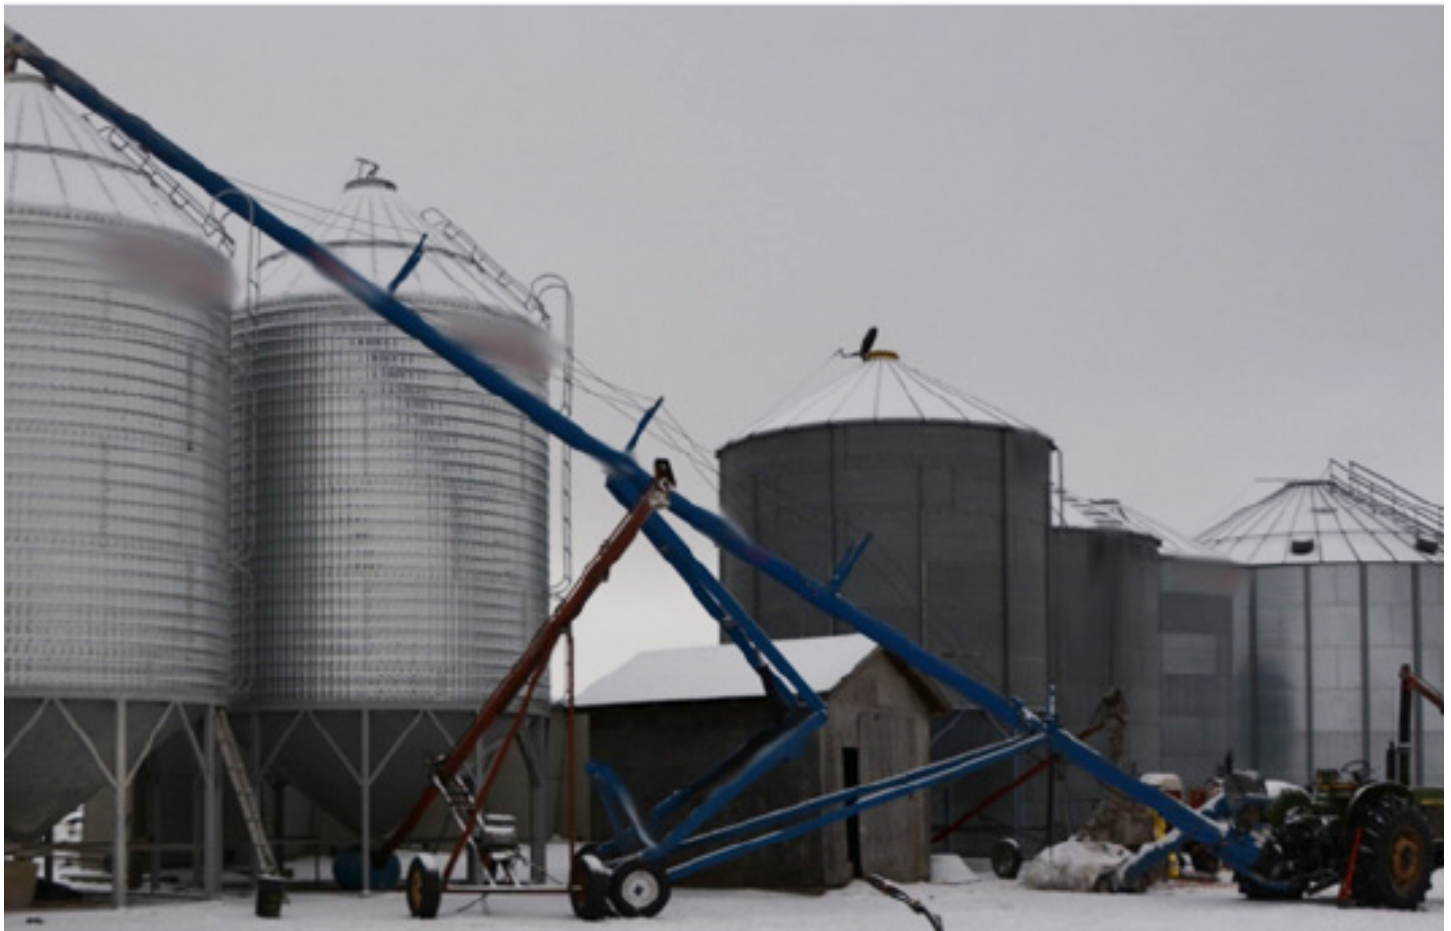
Figure 1

This photograph provides a view of the entire worksite. The feed processing system included two augers, two tractors and a grain mill. One tractor powered the grain mill while the other powered the blue auger. The grain mill and one of the tractors are not visible in this photo (Figure 1).

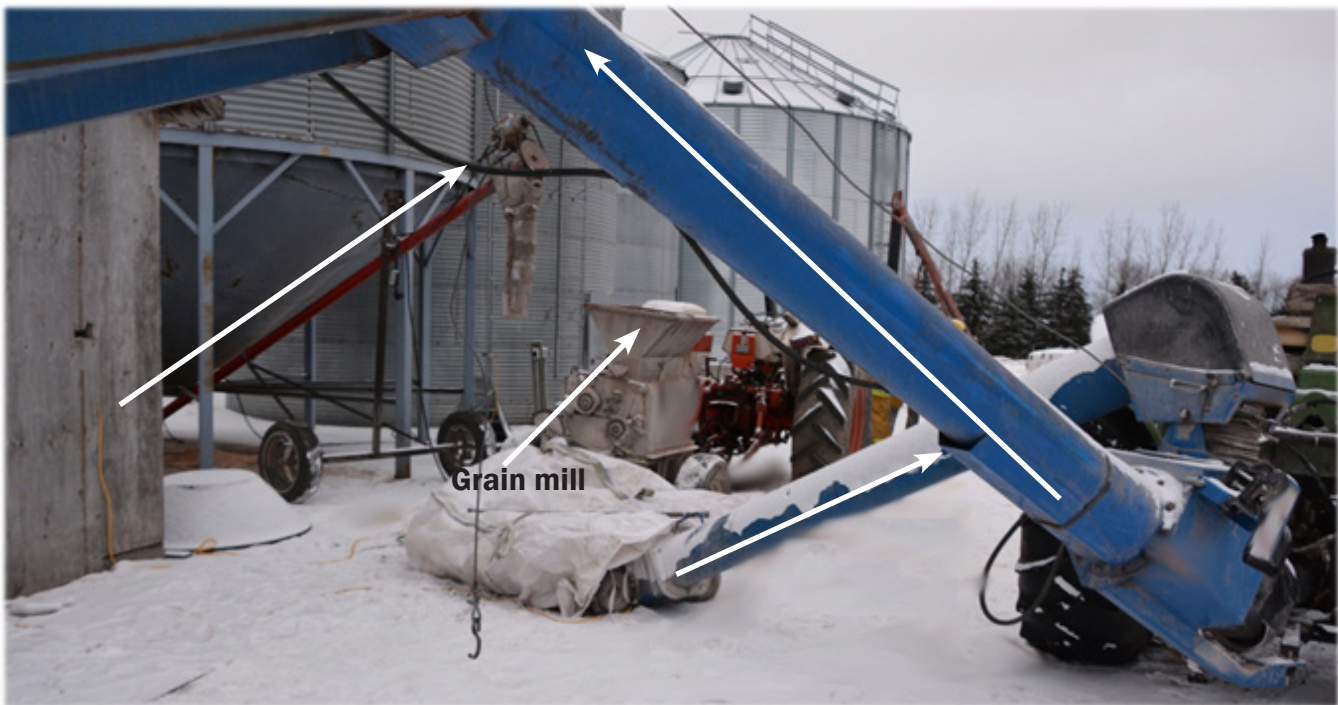
Figure 2

When the incident occurred the red, electrically powered auger was drawing barley from the bottom of one grain bin and passing it through the grain mill. The blue auger was transferring the processed barley from the grain mill to another bin nearby (Figure 2).

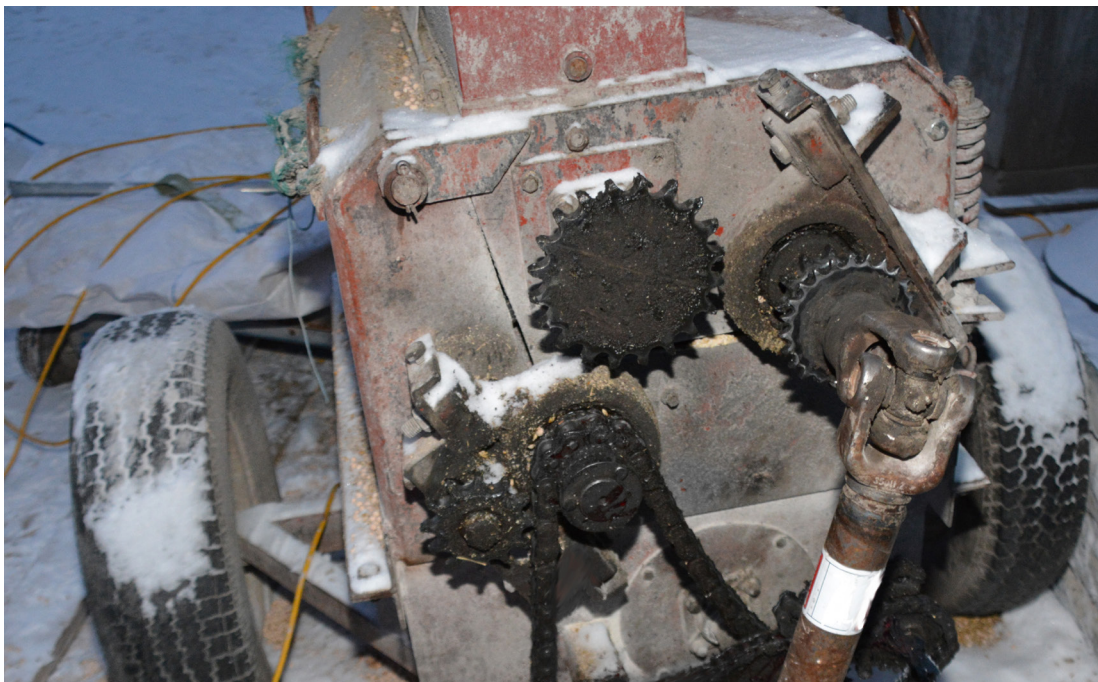
Figure 3

Rollers inside a grain mill crack and process various types of grain prior to feeding livestock, ensuring the animals can easily digest the food. There were no guards covering the moving parts on the front of the grain mill and its rotating PTO shaft when the worker was harmed (Figure 3).

The employer plead guilty to clause 137(1)(a) of *The Occupational Health and Safety Regulations, 1996*, being an employer failed to provide an effective safeguard where a worker may contact a dangerous moving part of a machine, resulting in the death of a worker. The employer was fined \$57,143 plus a victim surcharge of \$22,857.

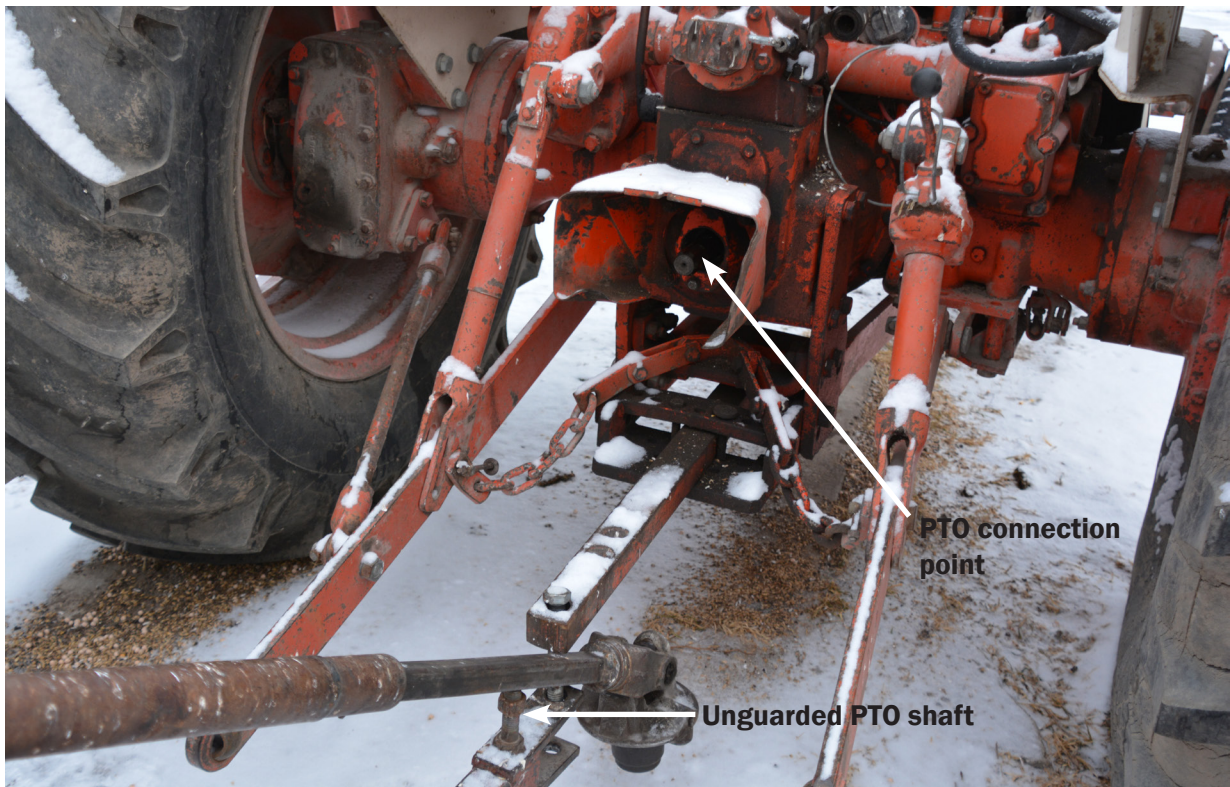
Figure 4

The grain mill's PTO shaft was connected to and energized through a tractor. The shaft rotated making the mill's rollers and gears move. In this photo, the unguarded PTO shaft– where the worker's clothing became caught– has been disengaged from its connection location on the tractor (Figure 4). Figure 5 is an example of a guarded PTO shaft connected to a different tractor.

No one was present when the incident occurred, however, it was determined that while visually checking the barley rolling process, the worker's clothing inadvertently contacted the grain mill's unguarded rotating PTO shaft. At that point, the clothing wrapped around the shaft trapping and fatally injuring the worker.
