**Workplace Fatality Summary Report:**

**Worker Fatally Injured While Installing Fascia**

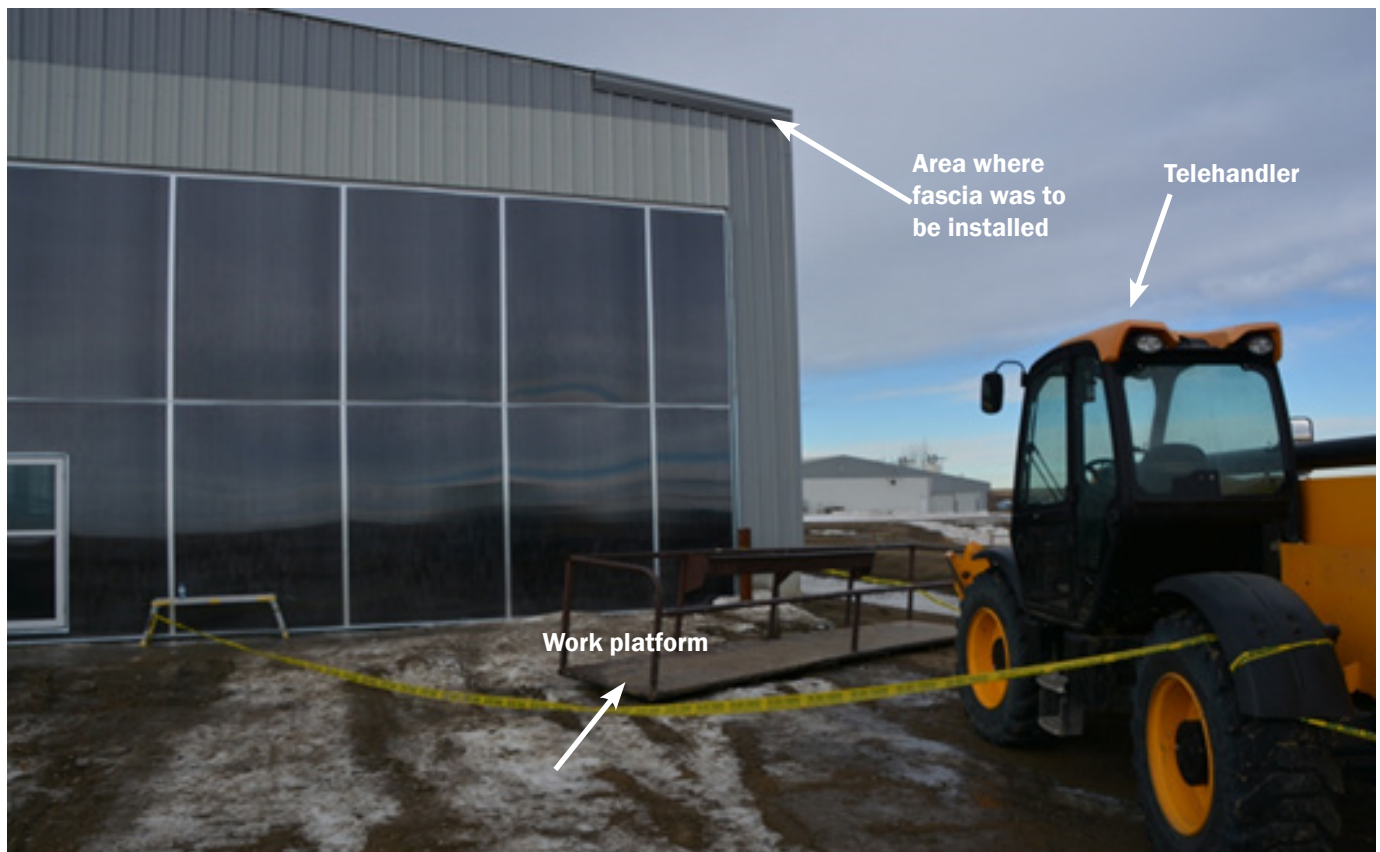
Figure 1 provides an overall view of the scene and shows the work platform and the telehandler.

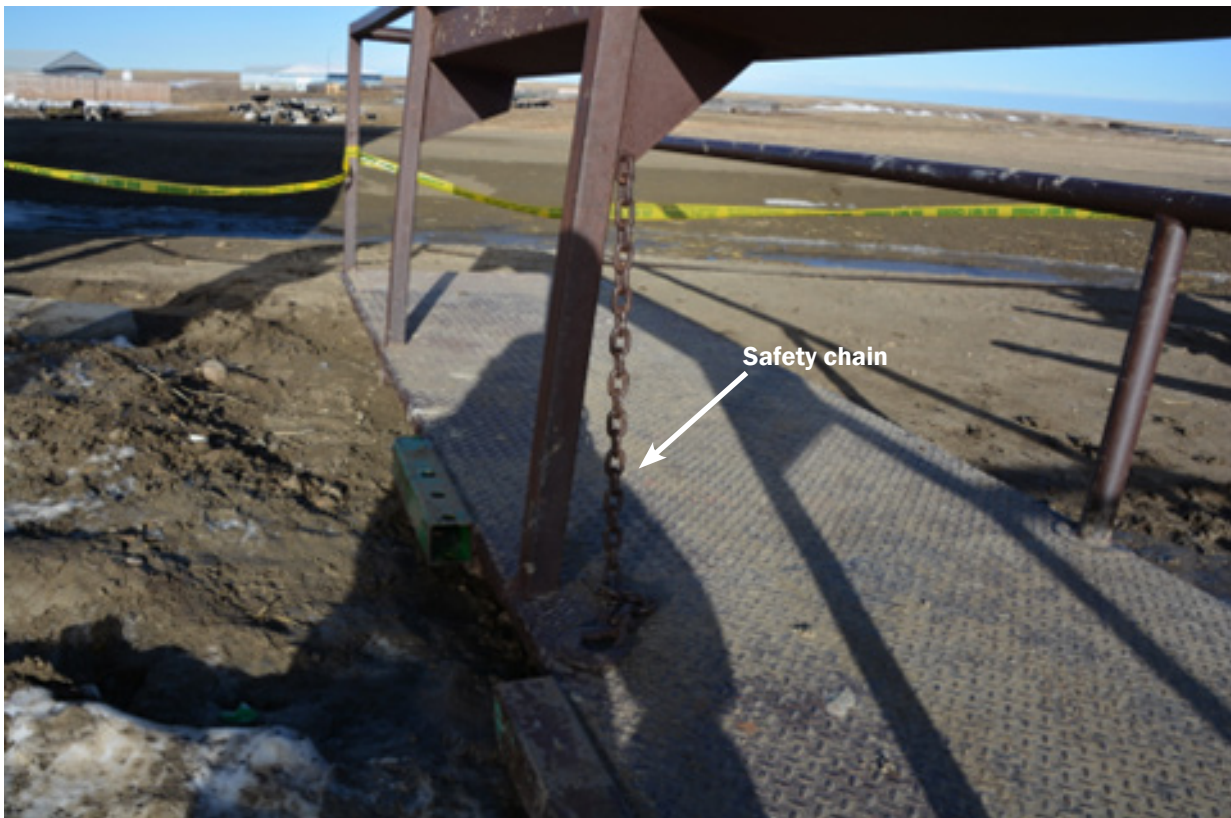
*Figure 2*

Figure 2 shows the platform that worker 1 was standing on during the time of the incident. A safety chain is welded onto the platform.

The forks of the telehandler were attached to the sleeves of the platform, but the safety chain was not attached to the carriage assembly of the telehandler. While worker 1 was situated on the platform, worker 2 began raising the platform to the top of the building so that worker 1 could complete the fascia installation. The forks of the telehandler tilted downwards, and the platform slid off the forks causing worker 1 to fall to approximately 25 feet to the ground. The platform subsequently fell on top of worker 1.

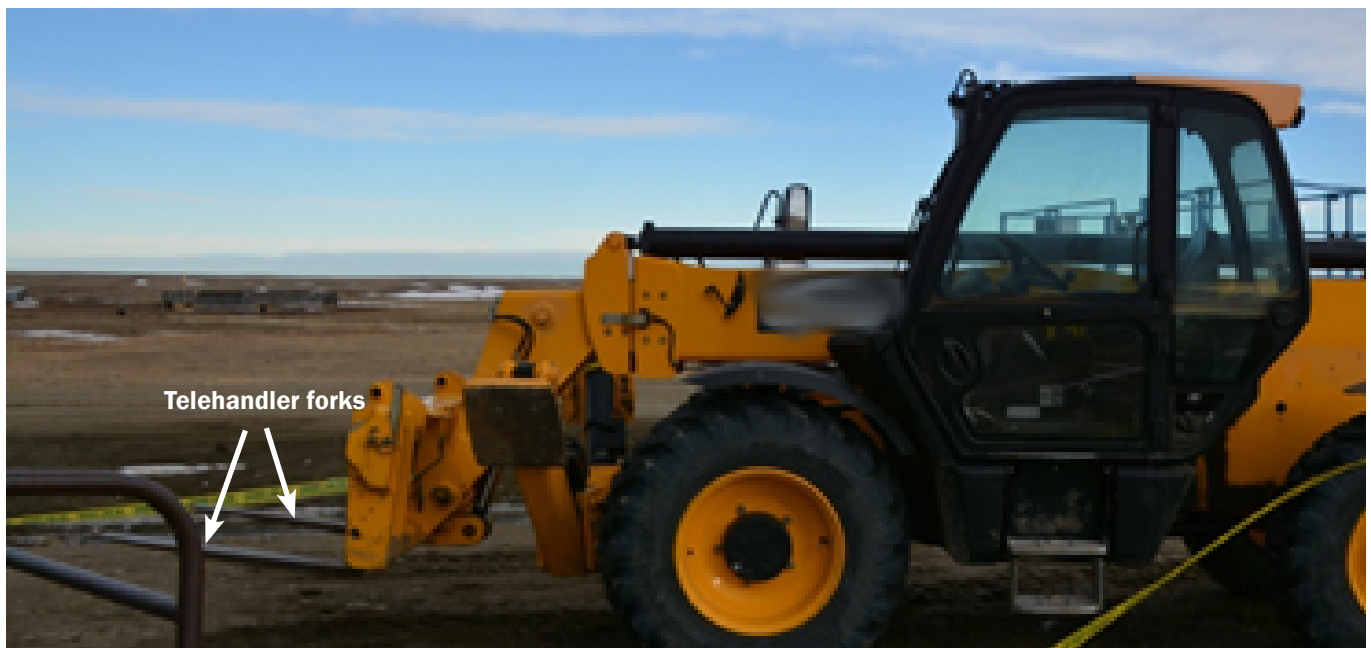
*Figure 3*

Figure 3 shows the configuration of the telehandler forks.

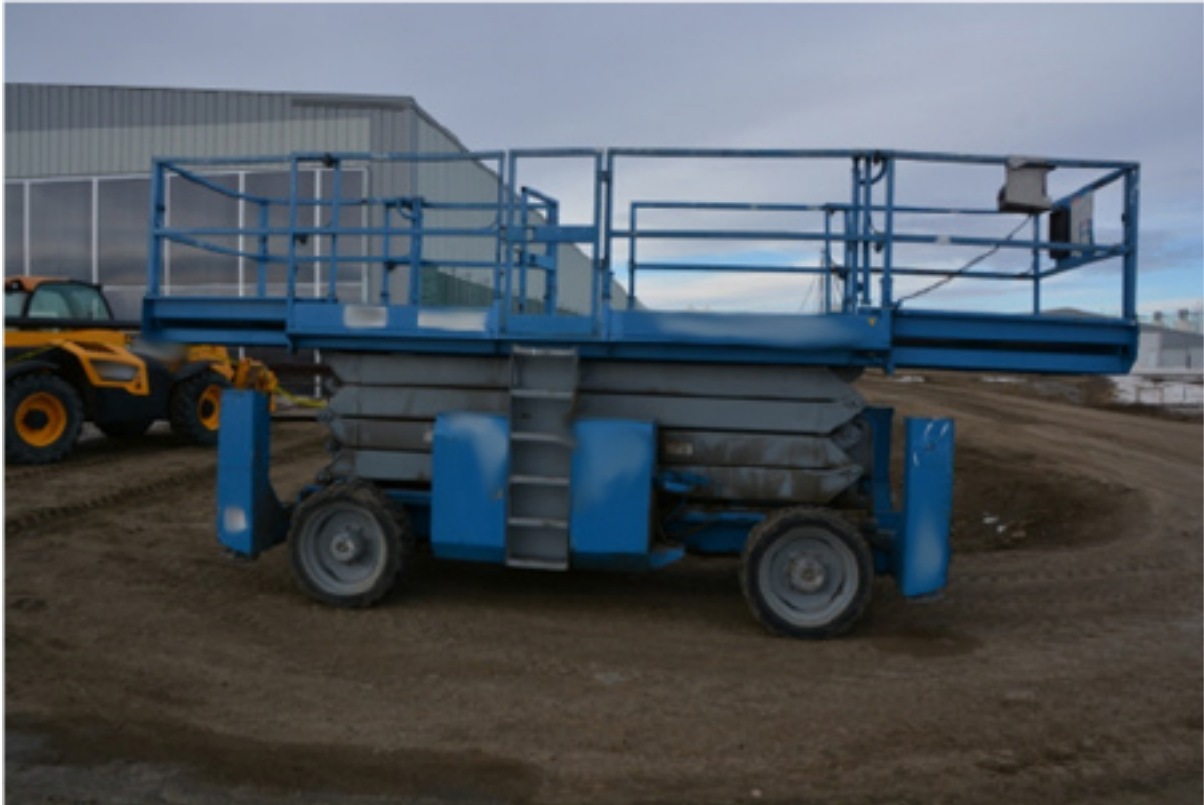
Figure 4 shows the scissor lift that was on site.

On the day of the incident, two workers were installing upper metal fascia to the top of the northwest corner of a cattle barn. On-site, there was a telehandler with forks and a scissor lift. The workers planned to use the scissor lift to elevate worker 1 to the top of the northeast side of the building. It was determined that the scissor lift could not be used because it would have been too far from the building when lifted to the required height and there would have been interference from obstructions. Worker 1 instructed worker 2 to retrieve the telehandler instead.
