**Workplace Fatality Summary Report:**

**Worker Fatally Injured While Loading Pipe Reel**

A worker was fatally injured when a hoisted reel of pipes became unstable and fell to the ground.

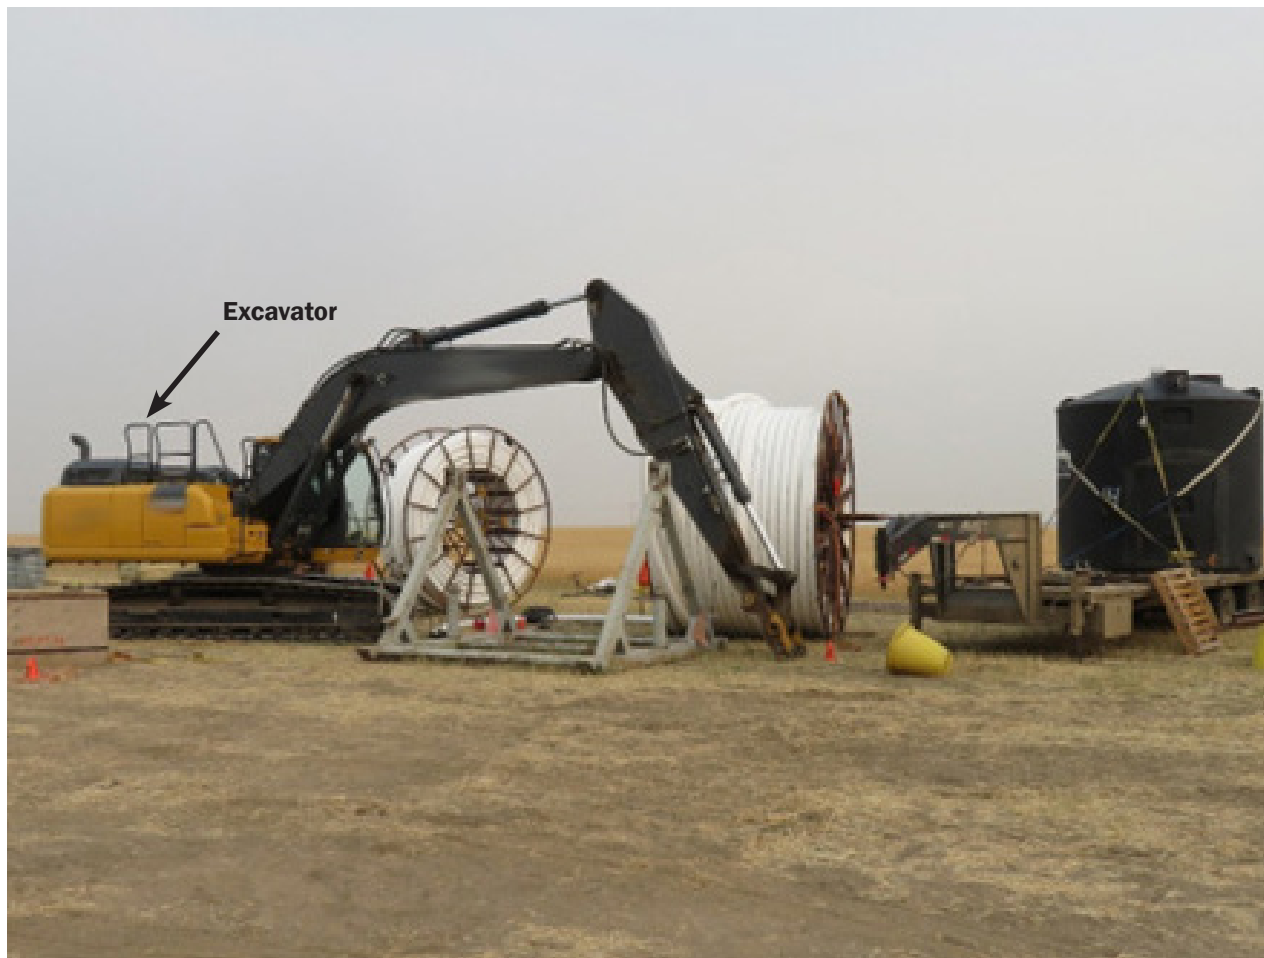
*Figure 1*

Figure 1 shows the excavator that was used to hoist the pipe reels.

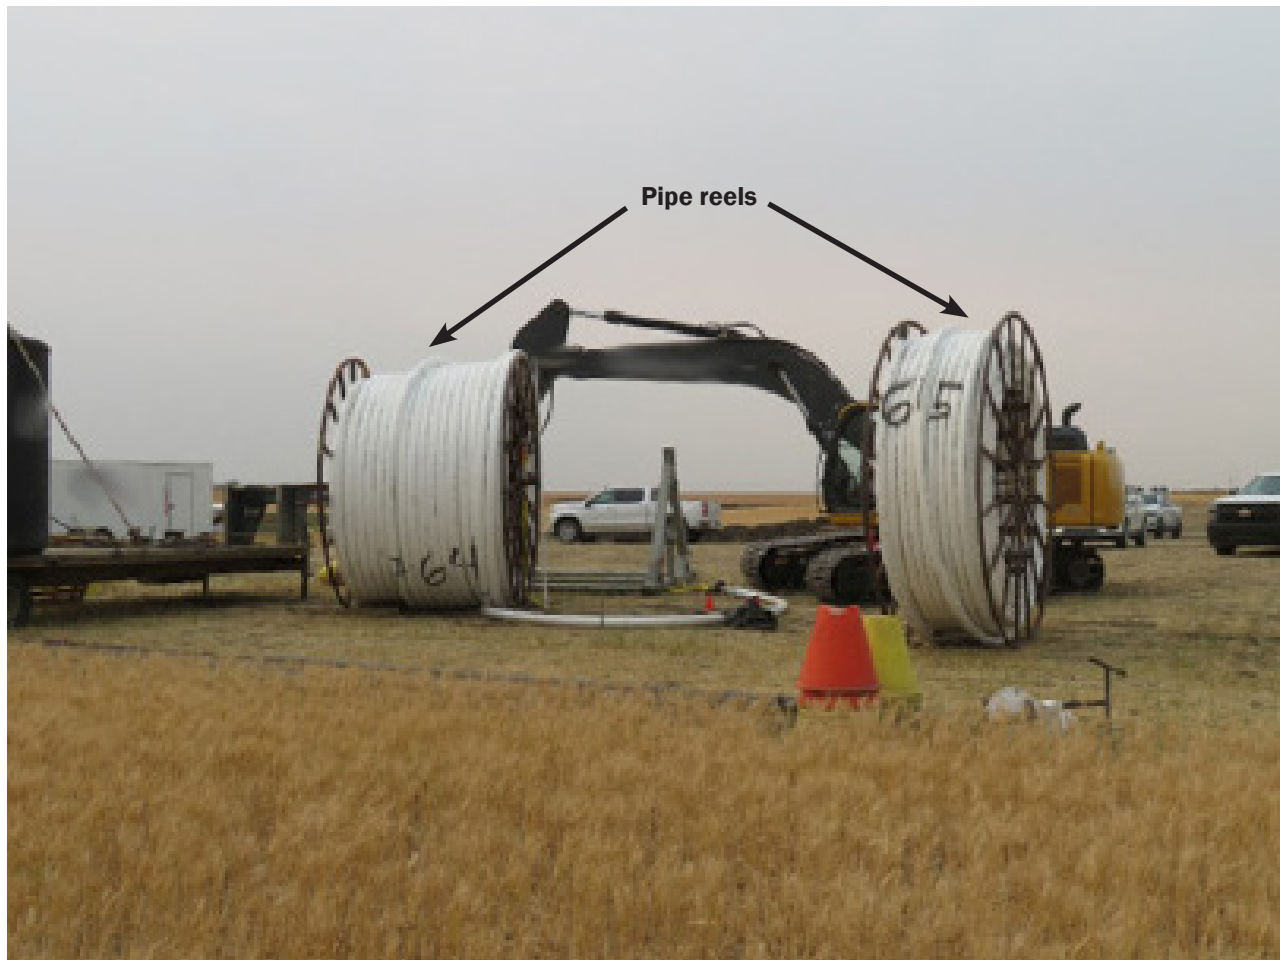
*Figure 2*

Figure 2 shows the pipe reels that were being lifted by the excavator.

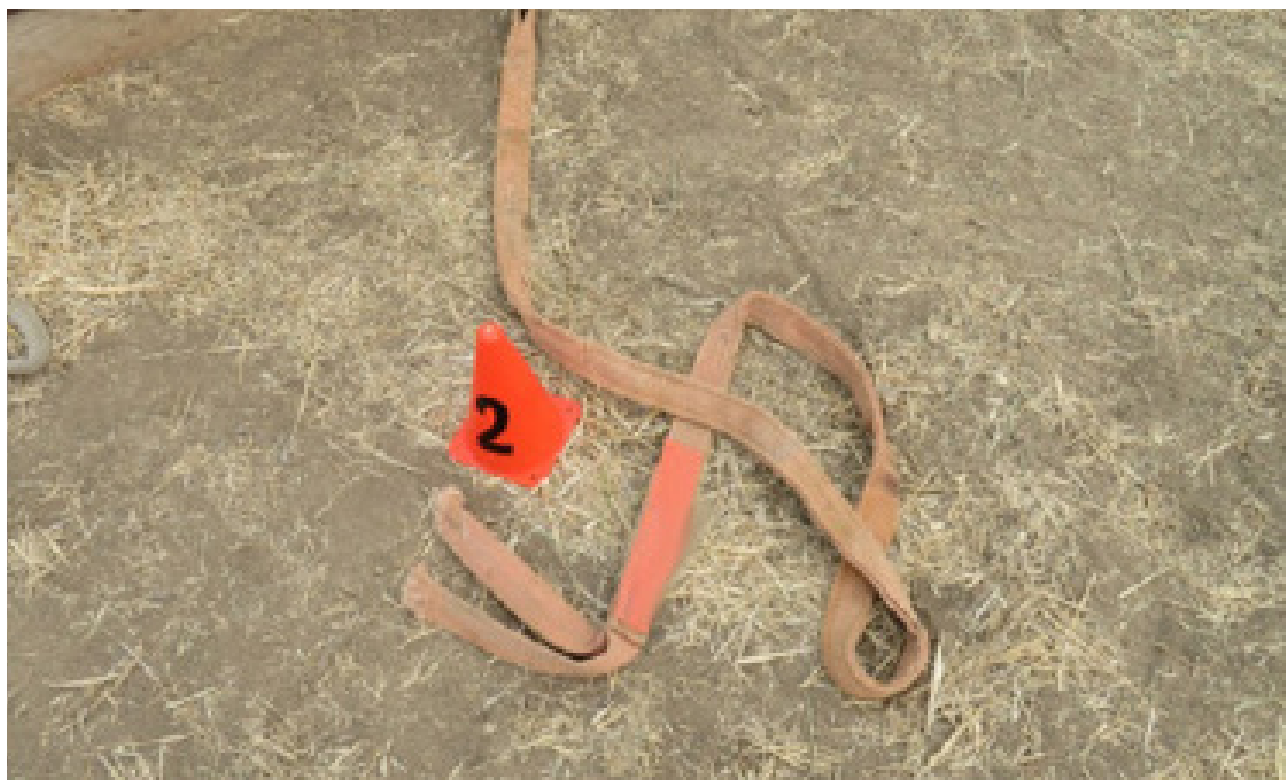
Figure 3 shows the polyester sling that was attached to the lifting lug.

The employer pleaded guilty to contravening clause 14-5(1)(b) of the *The Occupational Health and Safety Regulations, 2020* (being an employer fail to ensure that a sling used to hoist a load and the slings fittings and attachments are suitable for, and capable of, supporting the load being hoisted, resulting in the death of a worker). The employer was fined \$178,571.43 plus a victim surcharge of \$71,428.57.

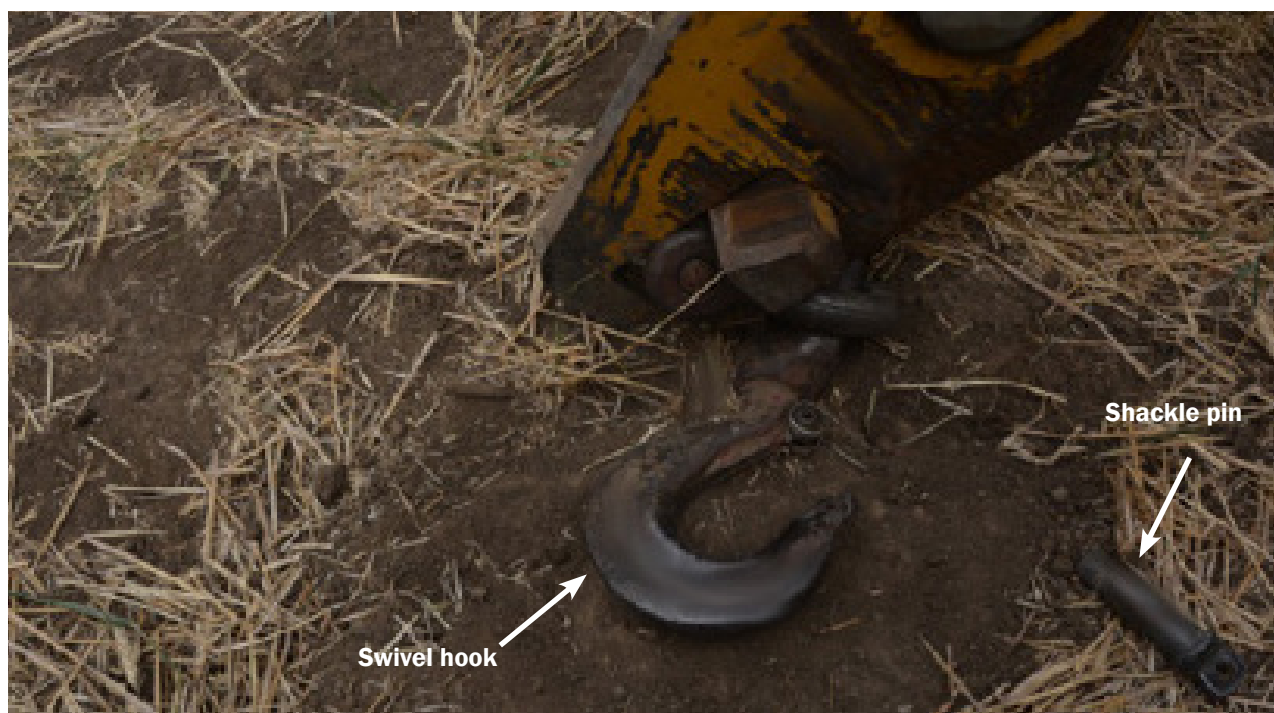
Figure 4 shows the swivel hook and the shackle pin.
